GEOTECHNICAL SITE INVESTIGATION

224 Invercauld Road Subdivision,
Stage 1B, Lot 102, Goonellabah,
NSW 2480.

ASCT Reference
[H19-1194.](#)

18th November 2019

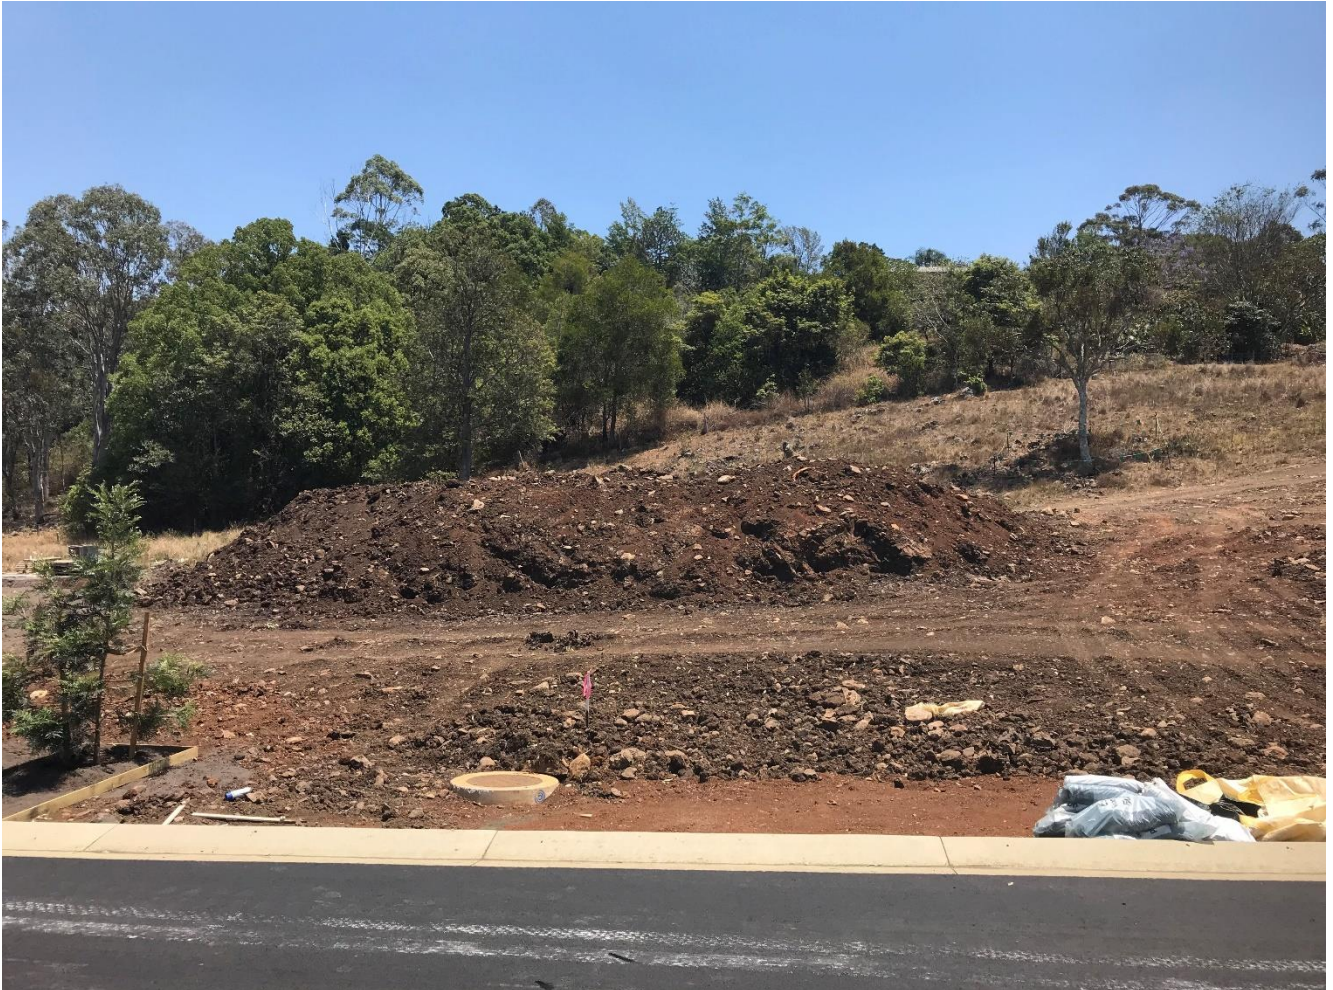
View of the site facing an easterly direction.

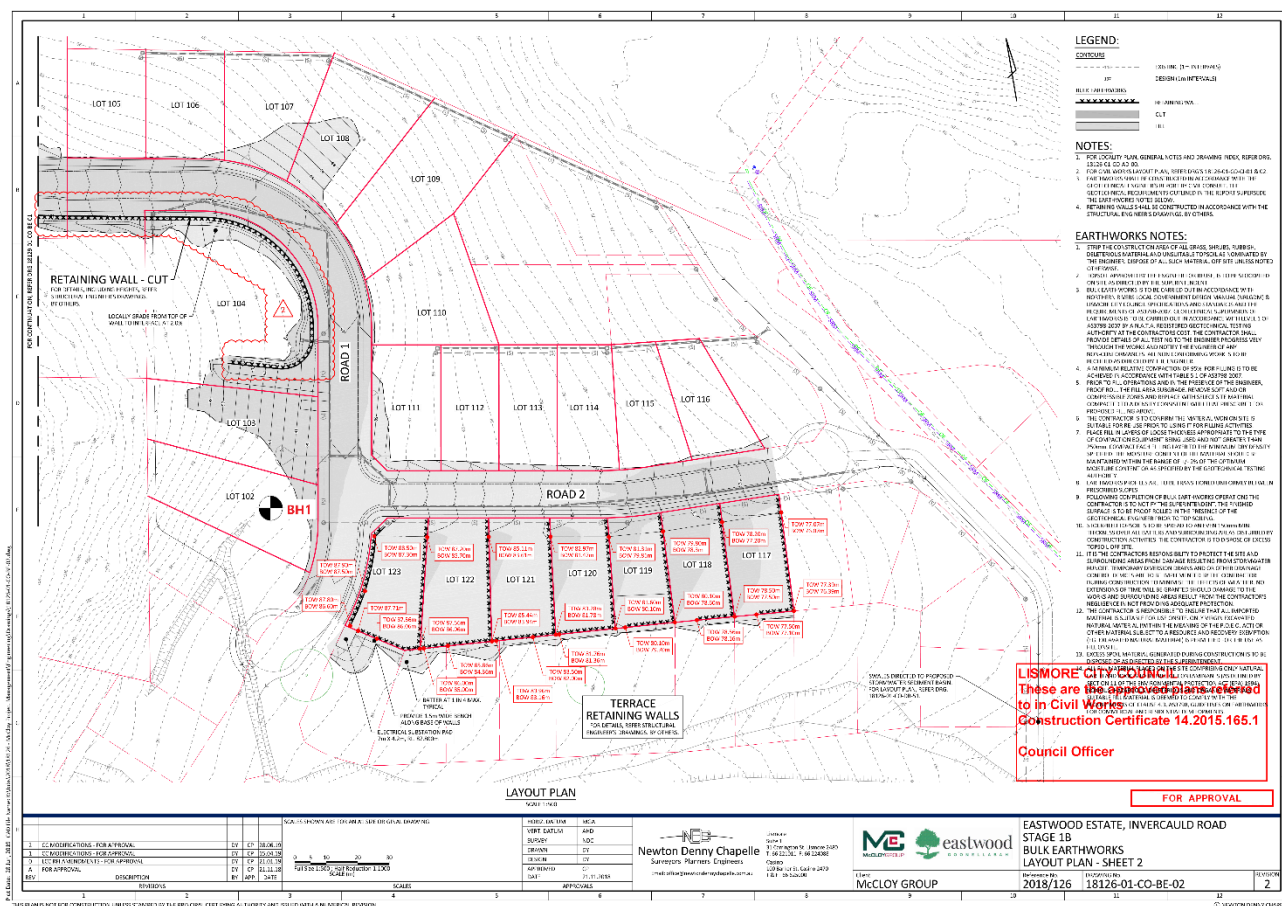
Plan of the site, with ASCT test positions (BH1).
