## GEOTECHNICAL SITE INVESTIGATION

224 Invercauld Road Subdivision,  
Stage 1B, Lot 122, Goonellabah,  
NSW 2480.

ASCT Reference  
[H19-1194.](#)

18<sup>th</sup> November 2019

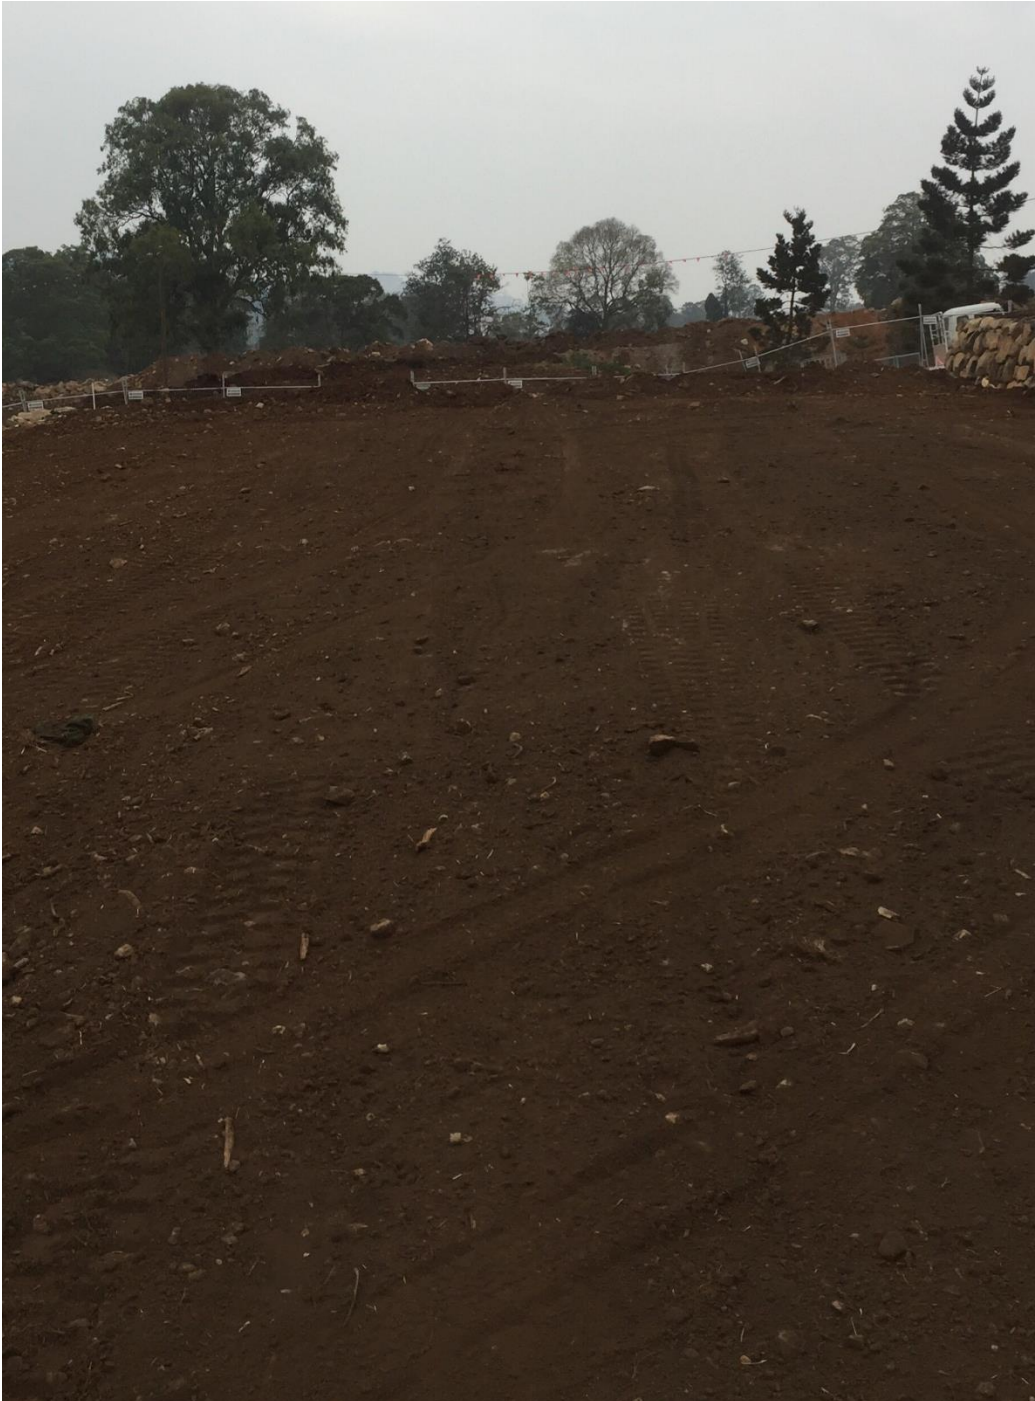
The sites surface is comprised of bare soil and slopes at approximately 2% towards the east.

Some outcropping of boulders is evident within the site.

**View of the site facing a southerly direction.**
