GEOTECHNICAL SITE INVESTIGATION

224 Invercauld Road Subdivision,
Stage 1B, Lot 103, Goonellabah,
NSW 2480.

ASCT Reference
[H19-1195.](#)

11th November 2019

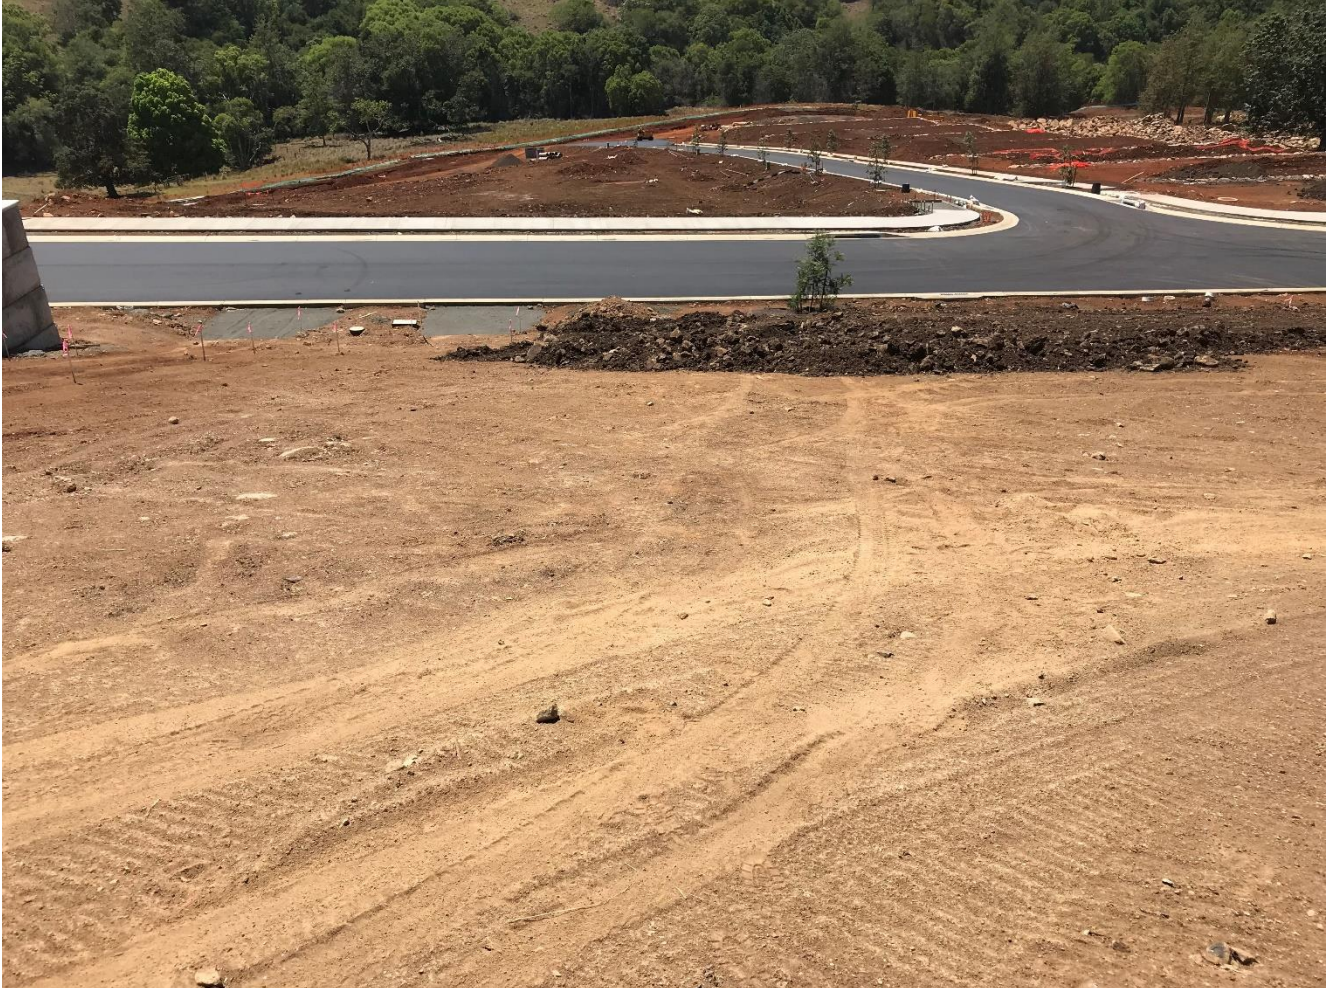
View of the site facing an easterly direction.
