GEOTECHNICAL SITE INVESTIGATION

224 Invercauld Road Subdivision,
Stage 1B, Lot 104, Goonellabah,
NSW 2480.

ASCT Reference
[H19-1196.](#)

18th November 2019

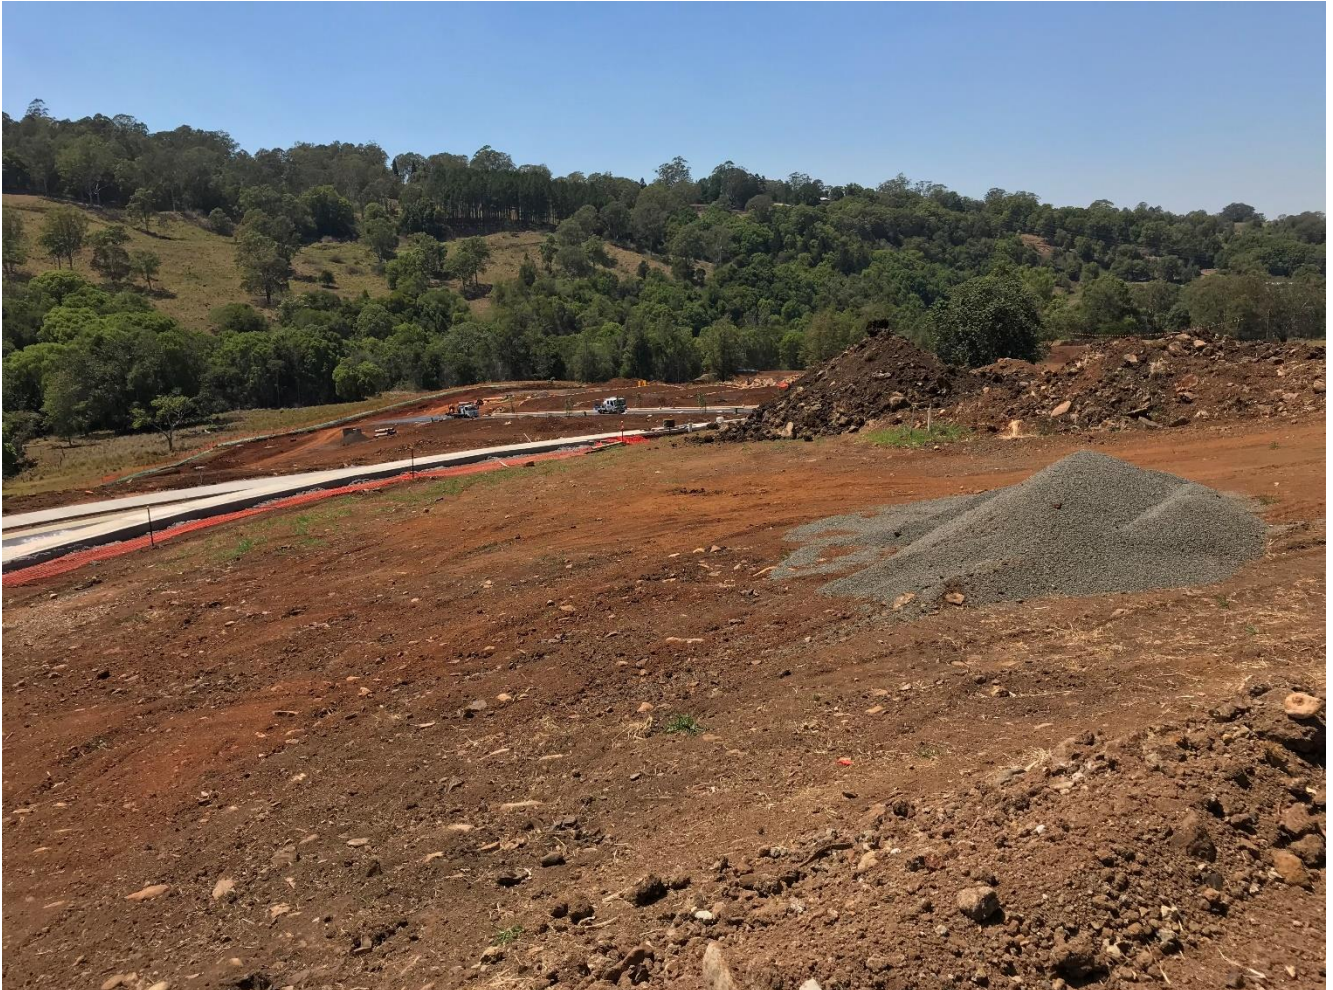
View of the site facing an east south-easterly direction.
