GEOTECHNICAL SITE INVESTIGATION

224 Invercauld Road Subdivision,
Stage 1B, Lot 106, Goonellabah,
NSW 2480.

ASCT Reference
[H19-1198.](#)

18th November 2019

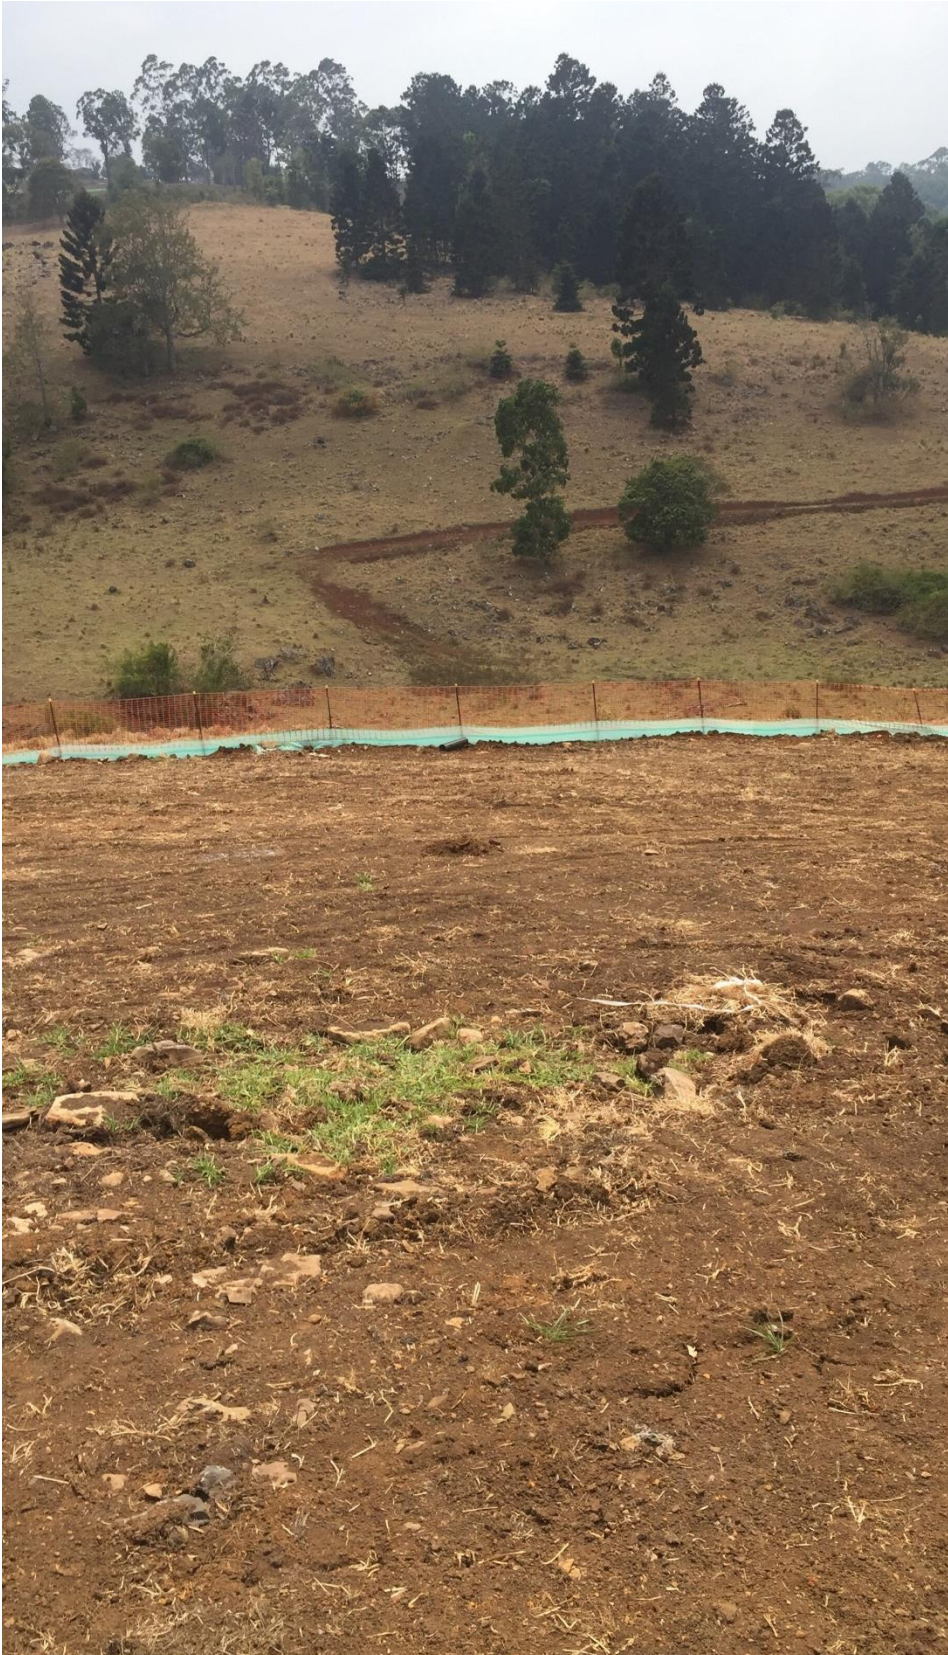
View of the site facing a northerly direction
