GEOTECHNICAL SITE INVESTIGATION

224 Invercauld Road Subdivision,
Stage 1B, Lot 107, Goonellabah,
NSW 2480.

ASCT Reference
[H19-1199.](#)

18th November 2019

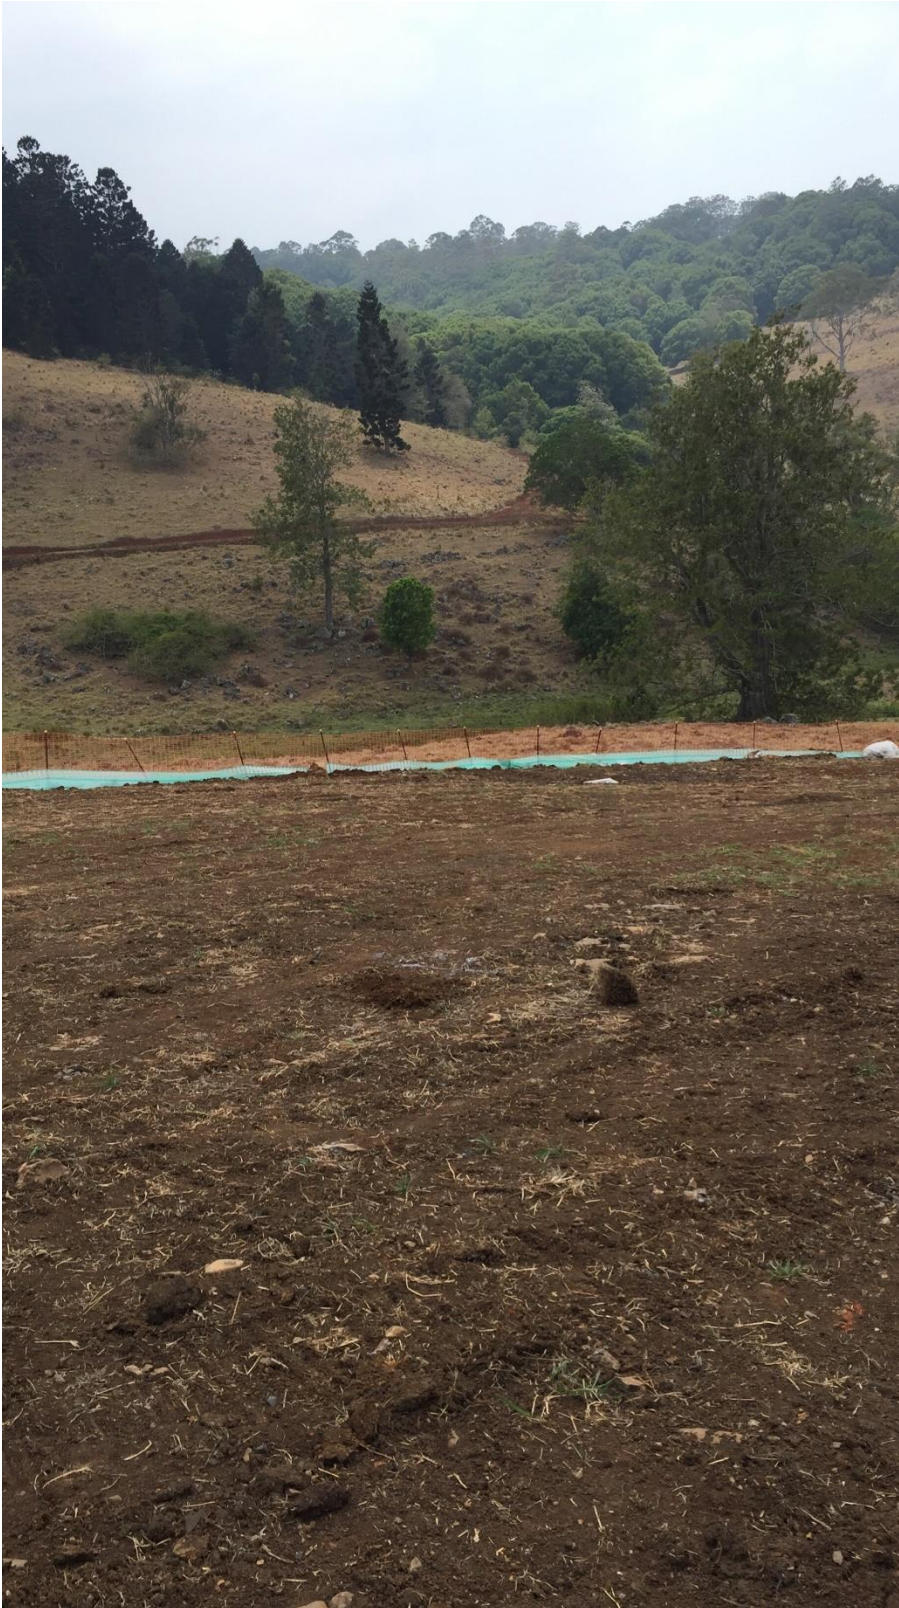
The sites surface is comprised of bare soil and slopes at approximately 20% towards the north north-east.

Some outcropping of large boulders is evident within the site.

View of the site facing a northerly direction.

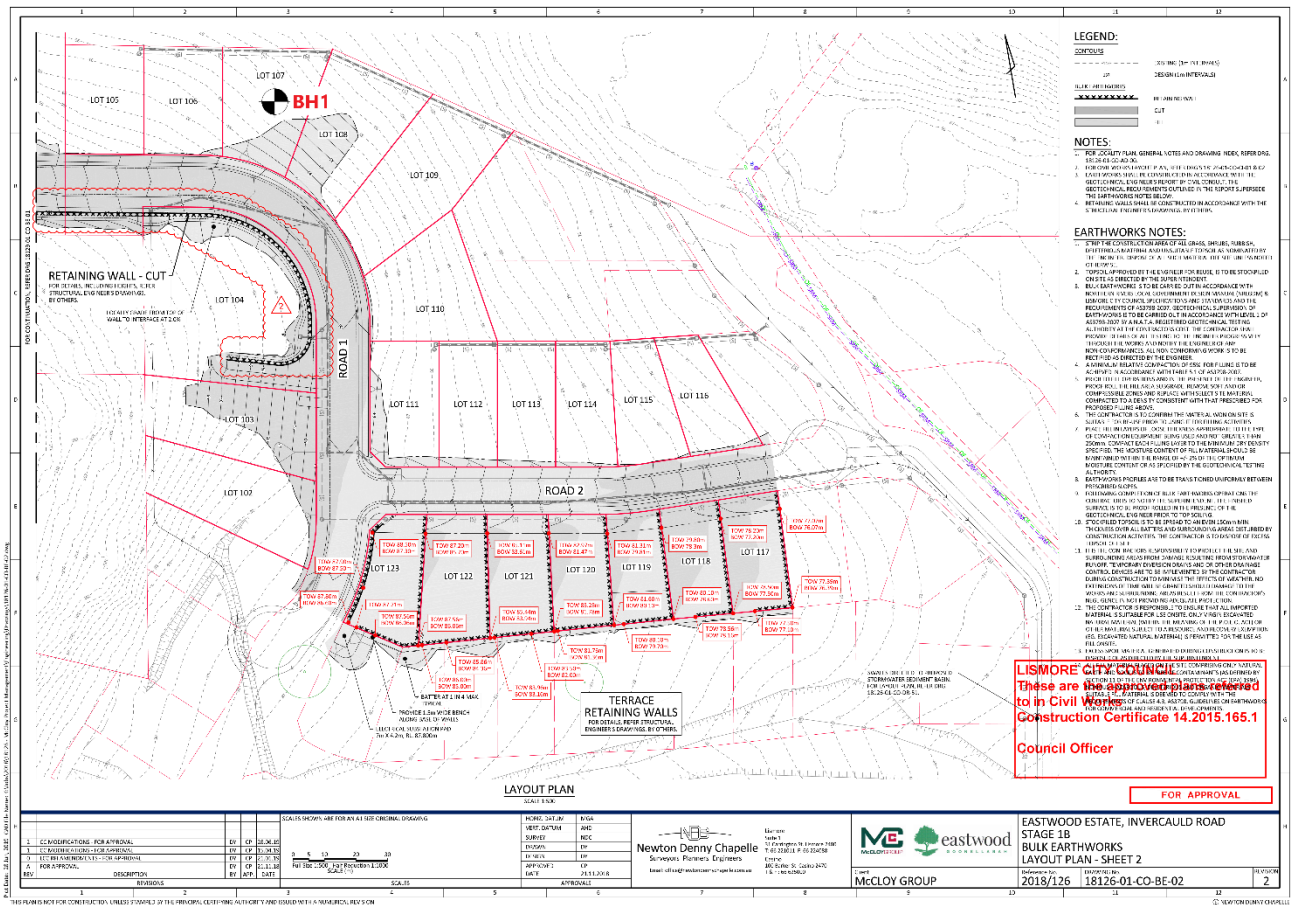
Plan of the site, with ASCT test positions (BH1).
