GEOTECHNICAL SITE INVESTIGATION

224 Invercauld Road Subdivision,
Stage 1B, Lot 109, Goonellabah,
NSW 2480.

ASCT Reference
[H19-1201.](#)

18th November 2019

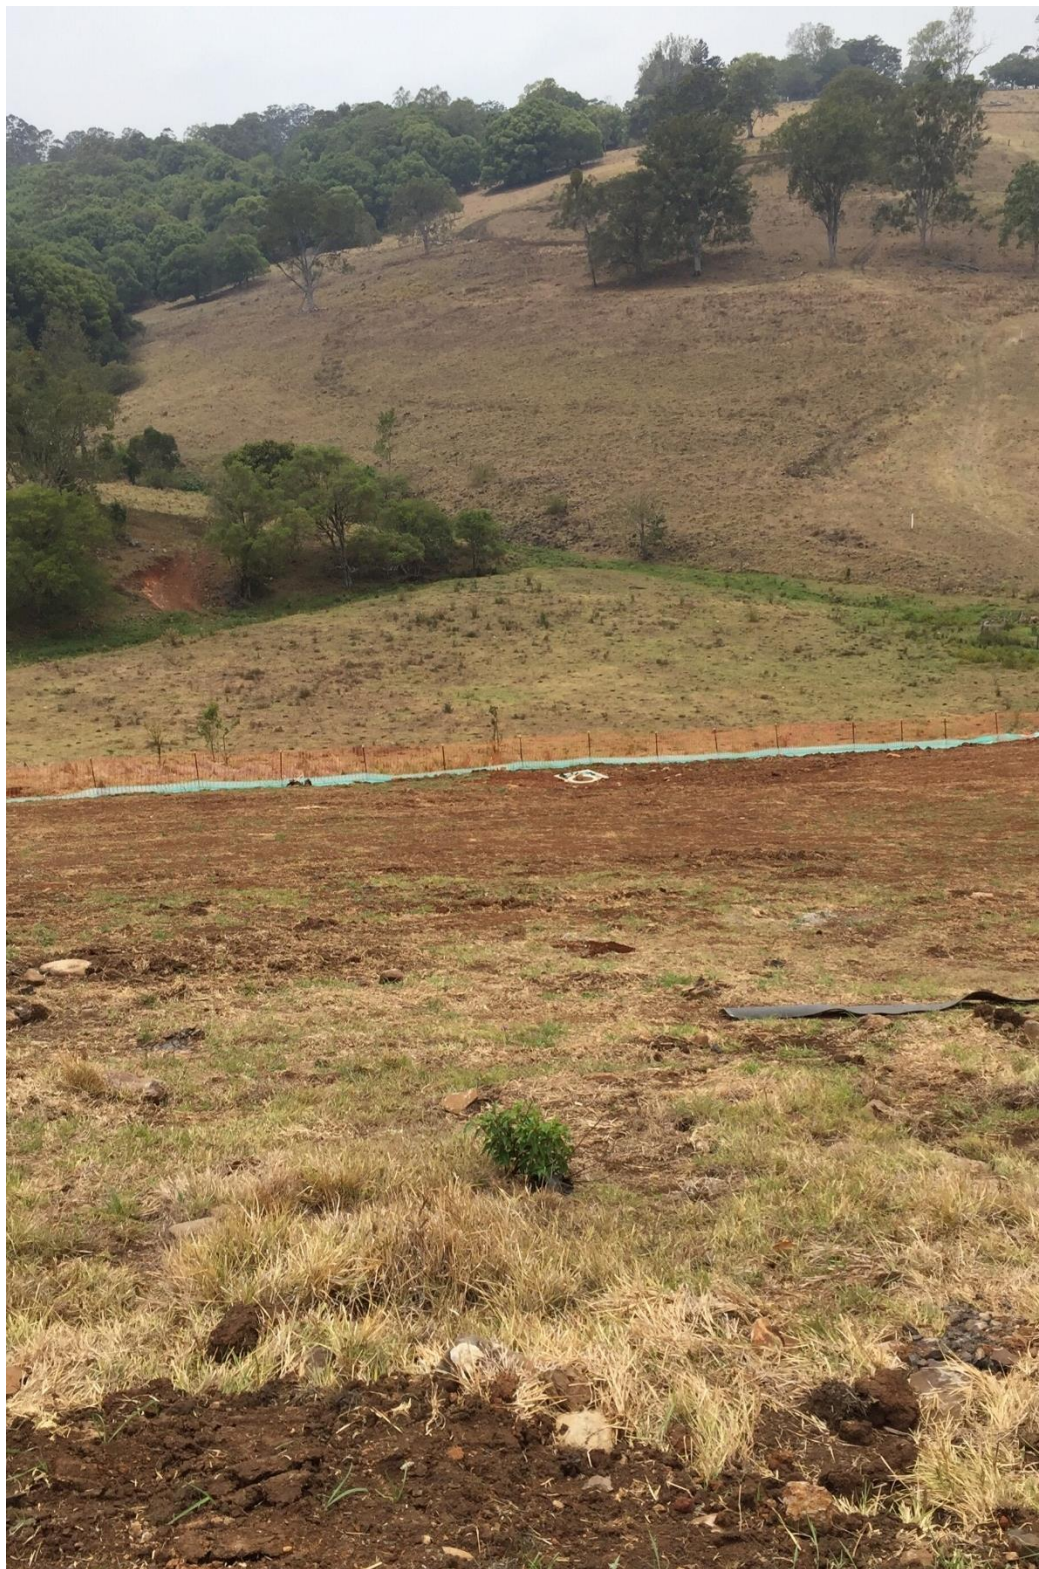
The sites surface is comprised of bare soil and slopes at approximately 24% towards the north east. The batter at the front of the lot slopes steeply at approximately 30% toward the north east.

Some outcropping of large boulders is evident within the site.

View of the site facing a north easterly direction.
