## GEOTECHNICAL SITE INVESTIGATION

Prepared by ASCT - Ballina office,  
for McCloy Group.

224 Invercauld Road Subdivision,  
Stage 1B, Lot 110, Goonellabah,  
NSW 2480.

ASCT Reference  
[H19-1202.](#)

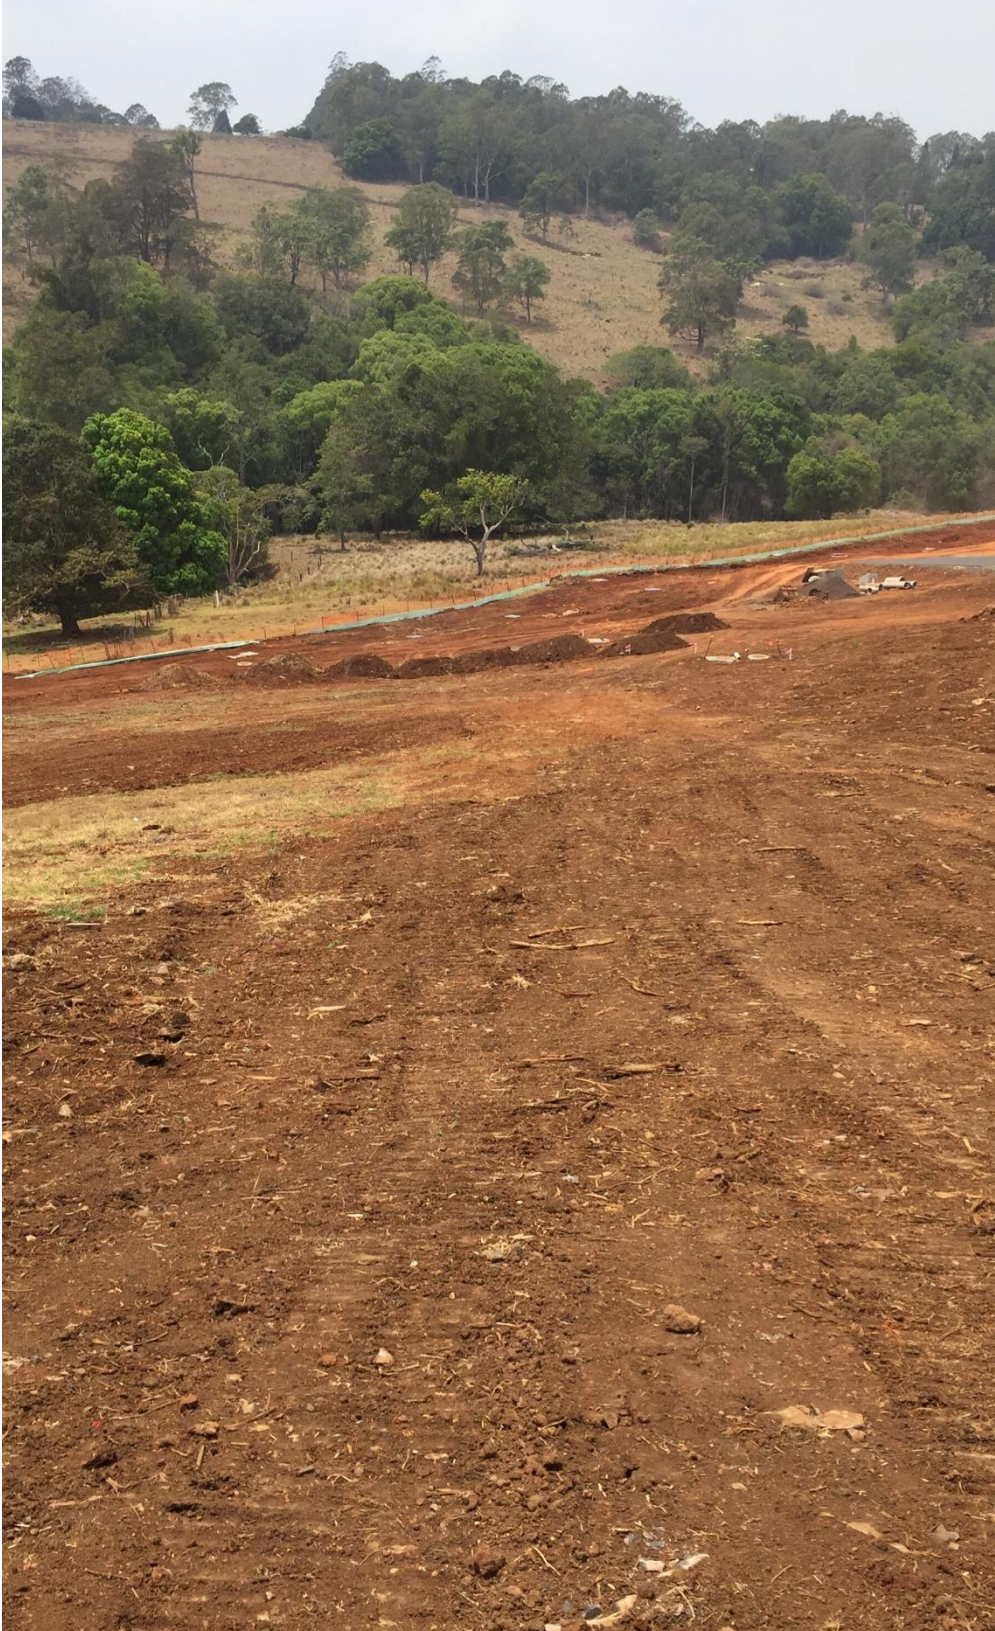
More specifically, the site is positioned in the mid-section of an east facing hill. The sites surface is comprised of bare soil and slopes at approximately 20% towards the east north-east. The batter at the front of the lot slopes at approximately 25% towards the east north-east.

Some outcropping of large boulders is evident within the site.

**View of the site facing an easterly direction.**
