GEOTECHNICAL SITE INVESTIGATION

224 Invercauld Road Subdivision,
Stage 1B, Lot 116, Goonellabah,
NSW 2480.

ASCT Reference
[H19-1208.](#)

18th November 2019

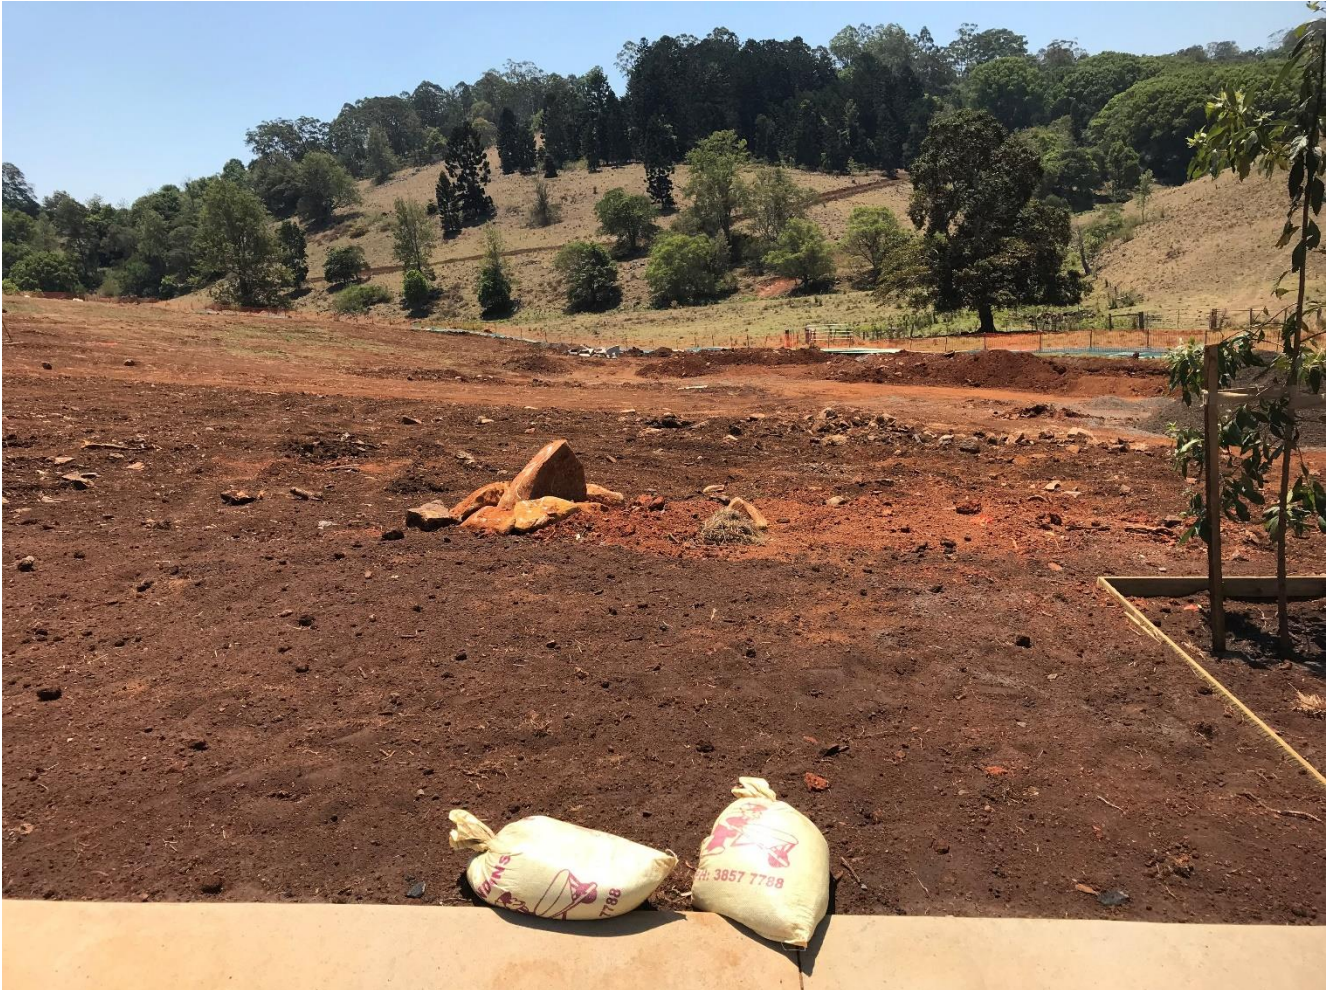
View of the site facing a northerly direction.
