## GEOTECHNICAL SITE INVESTIGATION

Prepared by ASCT - Ballina office,  
for McCloy Group

224 Invercauld Road Subdivision,  
Stage 1B, Lot 117, Goonellabah,  
NSW 2480.

ASCT Reference  
[H19-1209.](#)

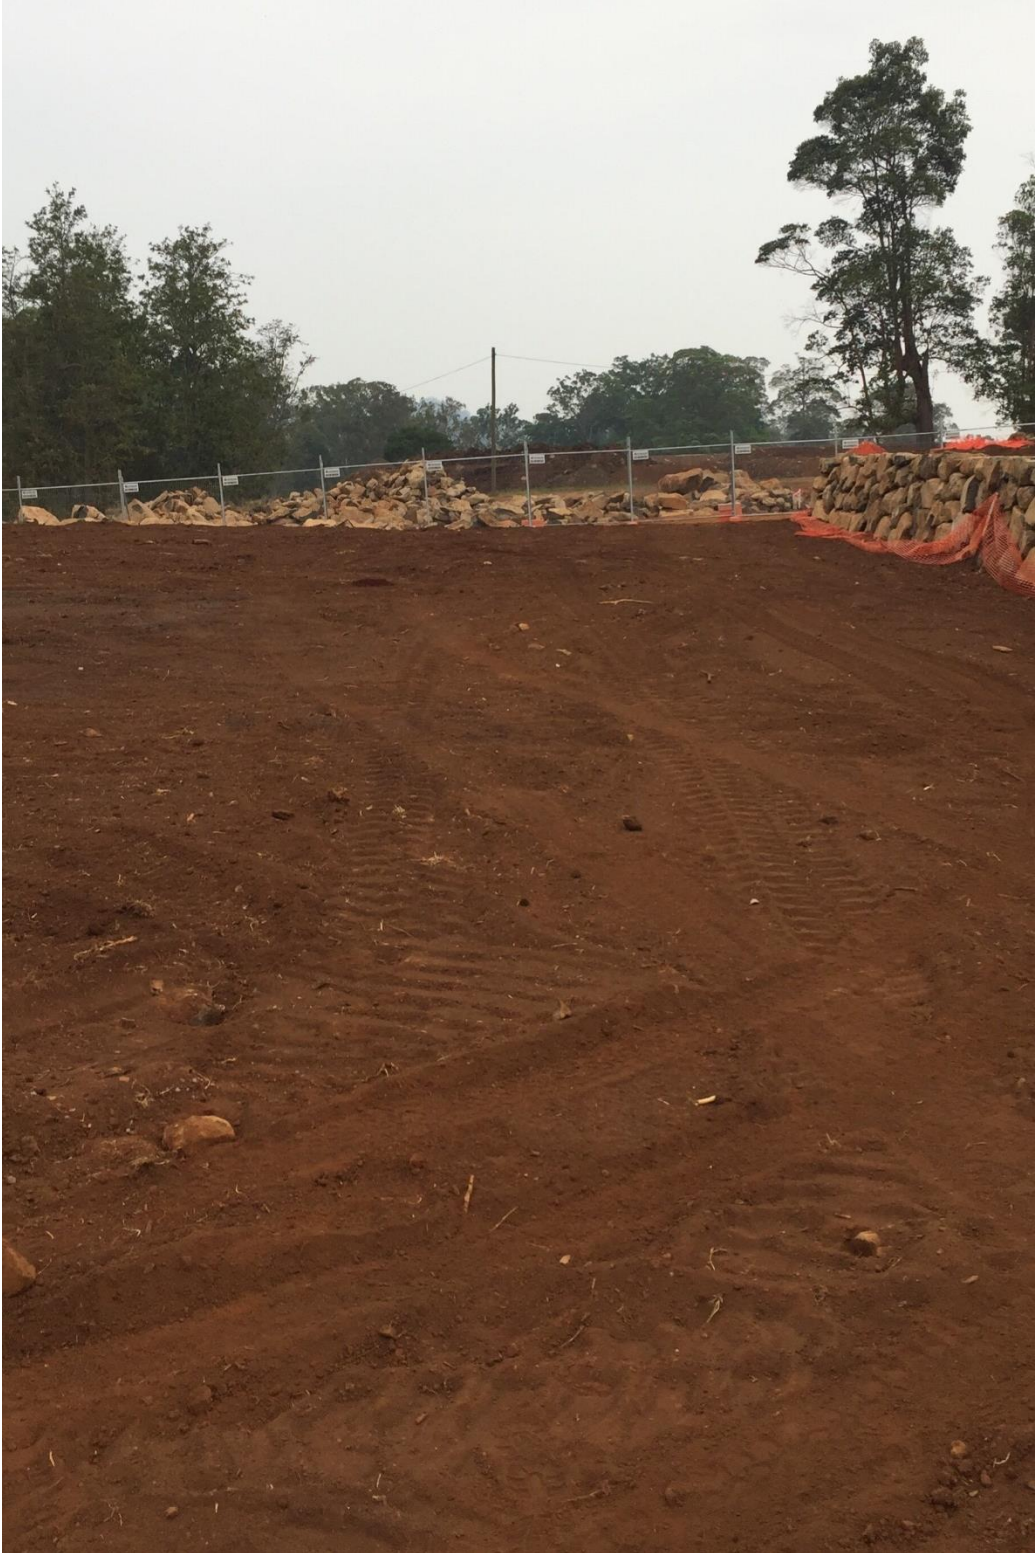
More specifically, the site is positioned in the mid-section of an east facing hill. The sites surface is comprised of bare soil and is predominately flat.

A rock retaining wall up to 1.0m in height was observed along the eastern and western property boundaries.

Some outcropping of boulders is evident within the site.

**View of the site facing a southerly direction.**
