## GEOTECHNICAL SITE INVESTIGATION

224 Invercauld Road Subdivision,  
Stage 1B, Lot 118, Goonellabah,  
NSW 2480.

ASCT Reference  
[H19-1210.](#)

18<sup>th</sup> November 2019

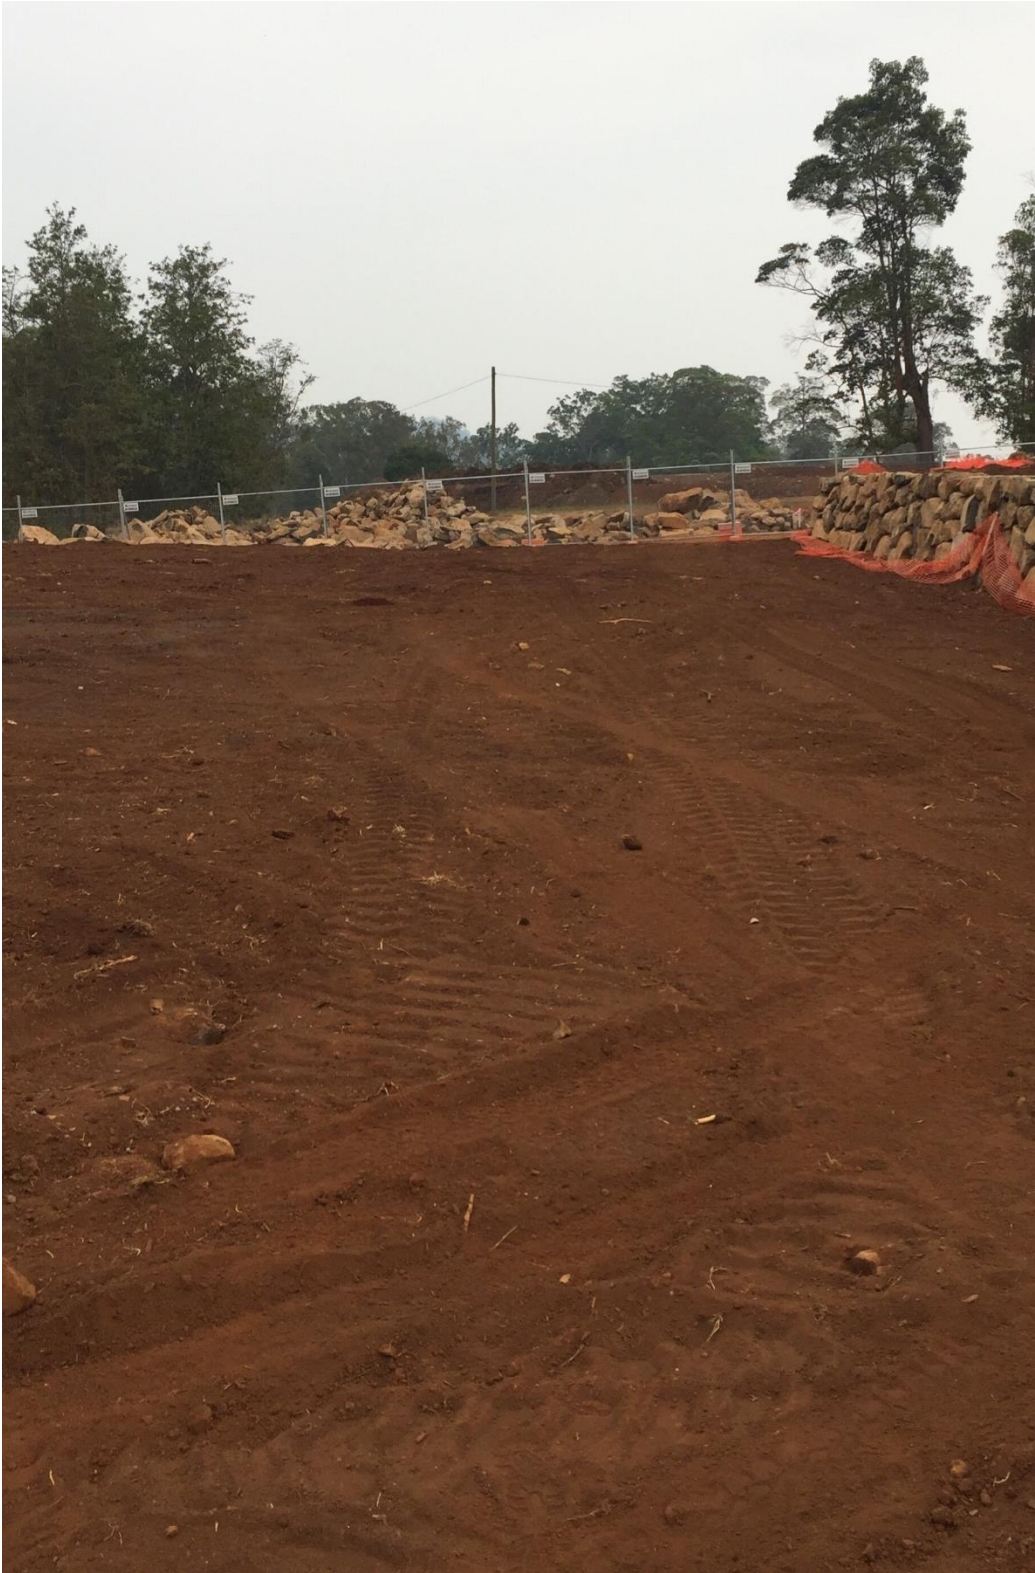
**View of the site facing a northerly direction.**
