## GEOTECHNICAL SITE INVESTIGATION

Prepared by ASCT - Ballina office,  
for McCloy Group.

224 Invercauld Road Subdivision,  
Stage 1B, Lot 119, Goonellabah,  
NSW 2480.

ASCT Reference  
[H19-1211.](#)

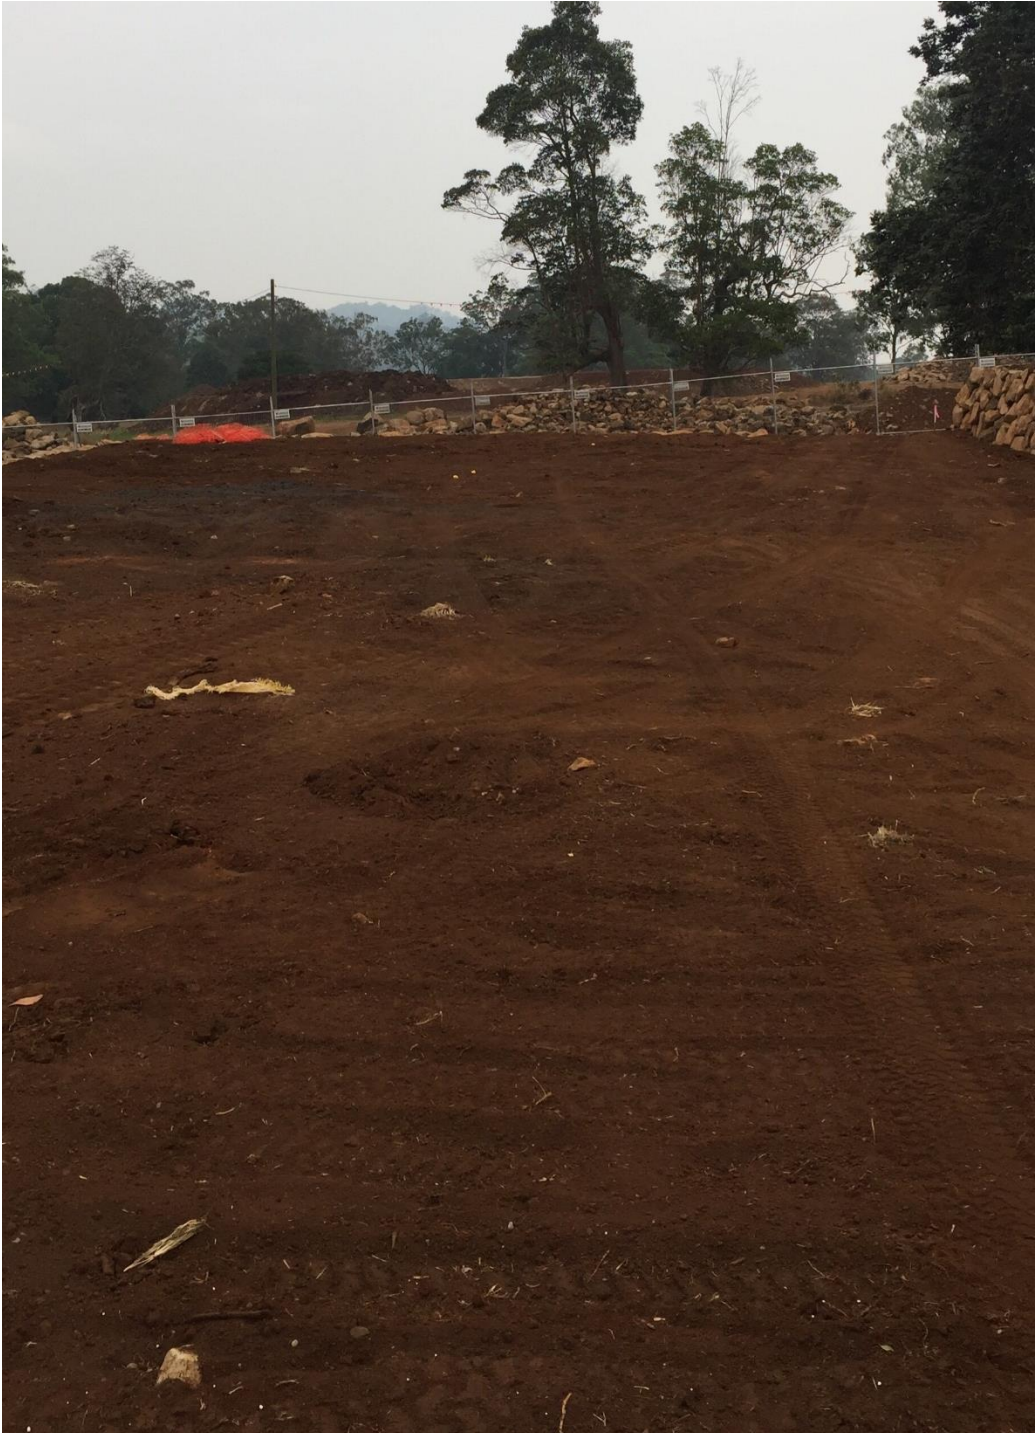
The sites surface is comprised of bare soil and is predominately flat.

A rock retaining wall up to 1.2m in height was observed along the eastern and western property boundaries.

Some outcropping of boulders is evident within the site.

**View of the site facing a southerly direction.**
