GEOTECHNICAL SITE INVESTIGATION

224 Invercauld Road Subdivision,
Stage 1B, Lot 120, Goonellabah,
NSW 2480.

ASCT Reference
[H19-1212.](#)

18th November 2019

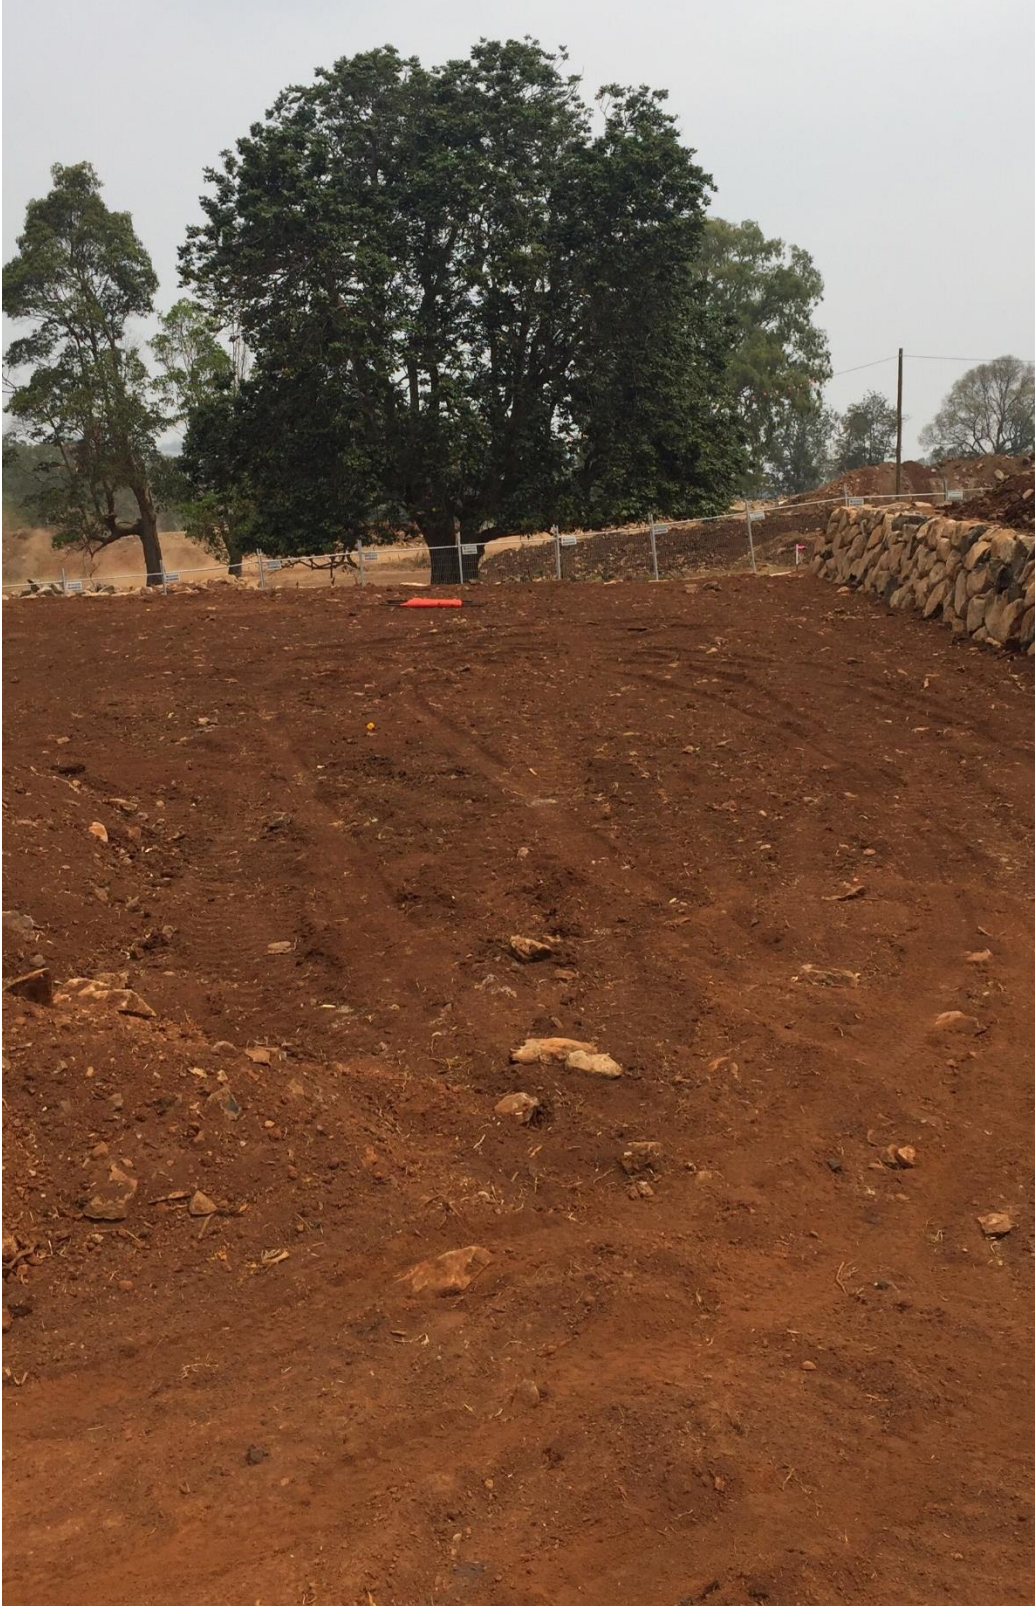
View of the site facing a southerly direction.

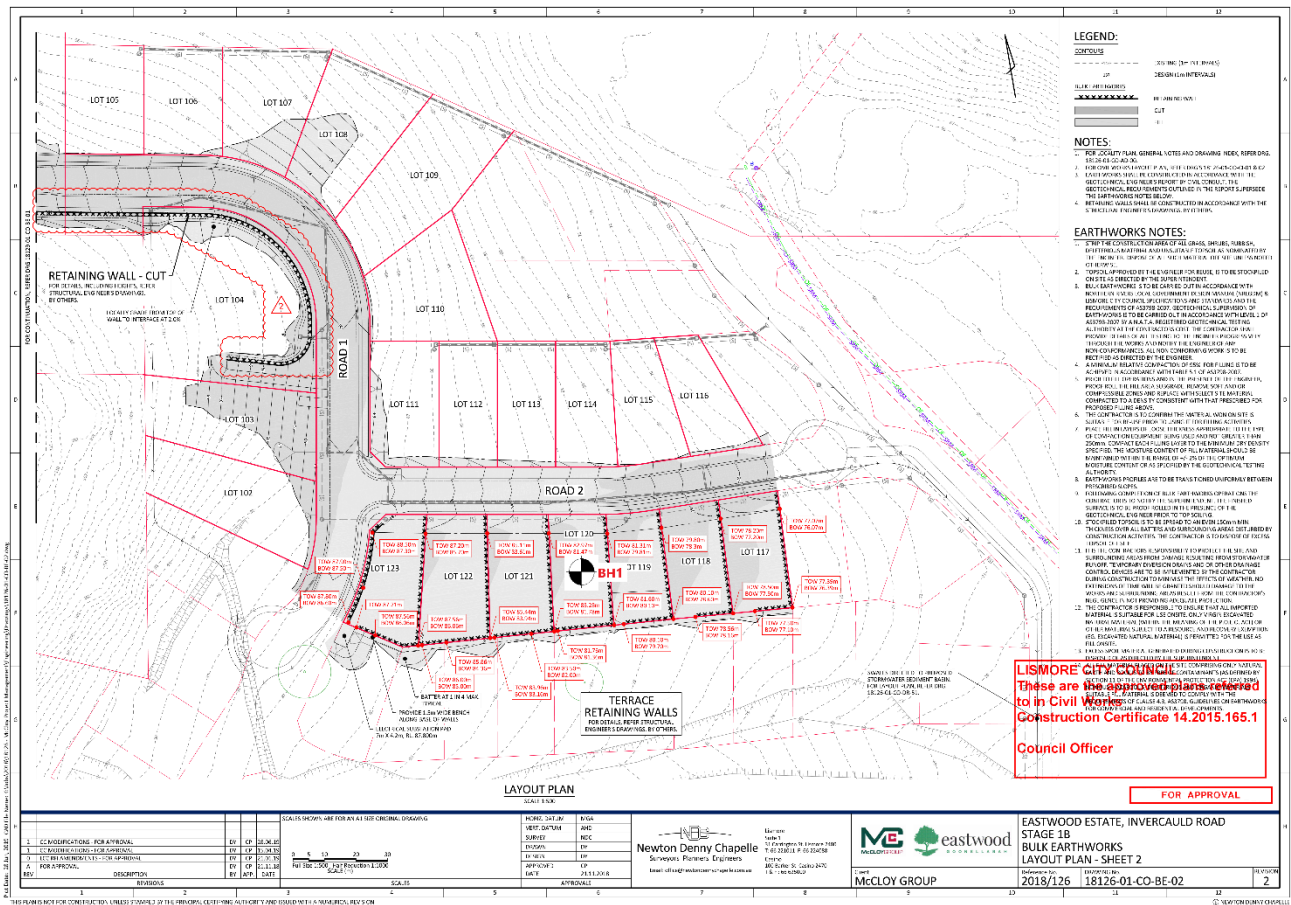
Plan of the site, with ASCT test positions (BH1).
