GEOTECHNICAL SITE INVESTIGATION

224 Invercauld Road Subdivision,
Stage 1B, Lot 121, Goonellabah,
NSW 2480.

ASCT Reference
[H19-1213.](#)

18th November 2019

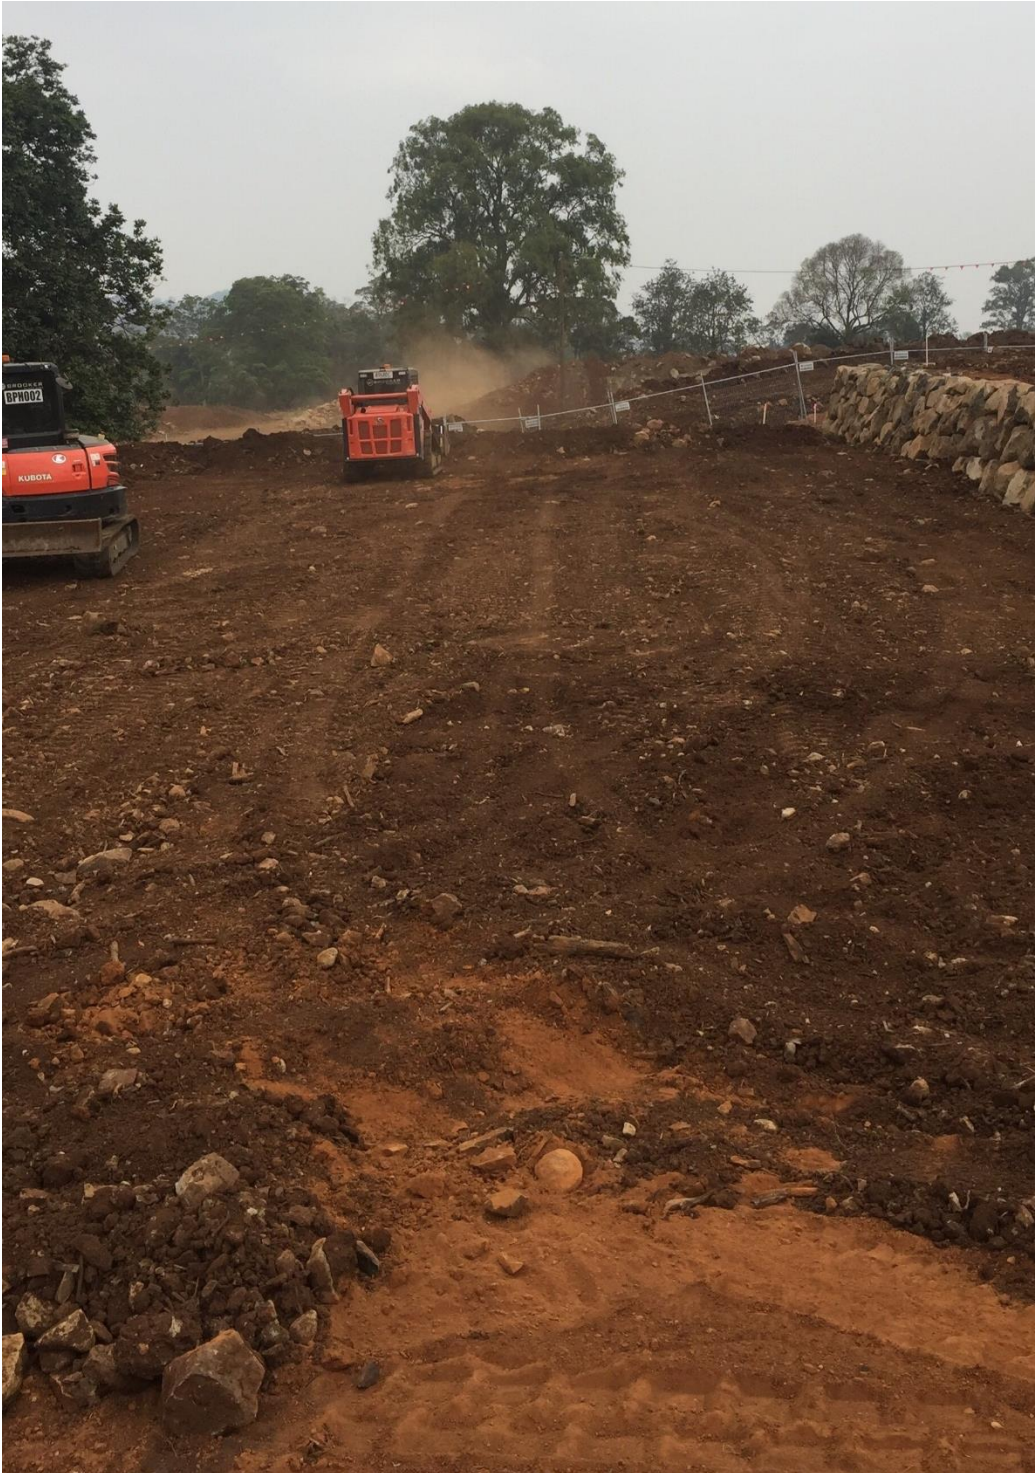
View of the site facing a southerly direction.
