GEOTECHNICAL SITE INVESTIGATION

Prepared by ASCT - Ballina office,
for McCloy Group.

224 Invercauld Road Subdivision,
Stage 1B, Lot 123, Goonellabah,
NSW 2480.

Ref No: H19-1215.

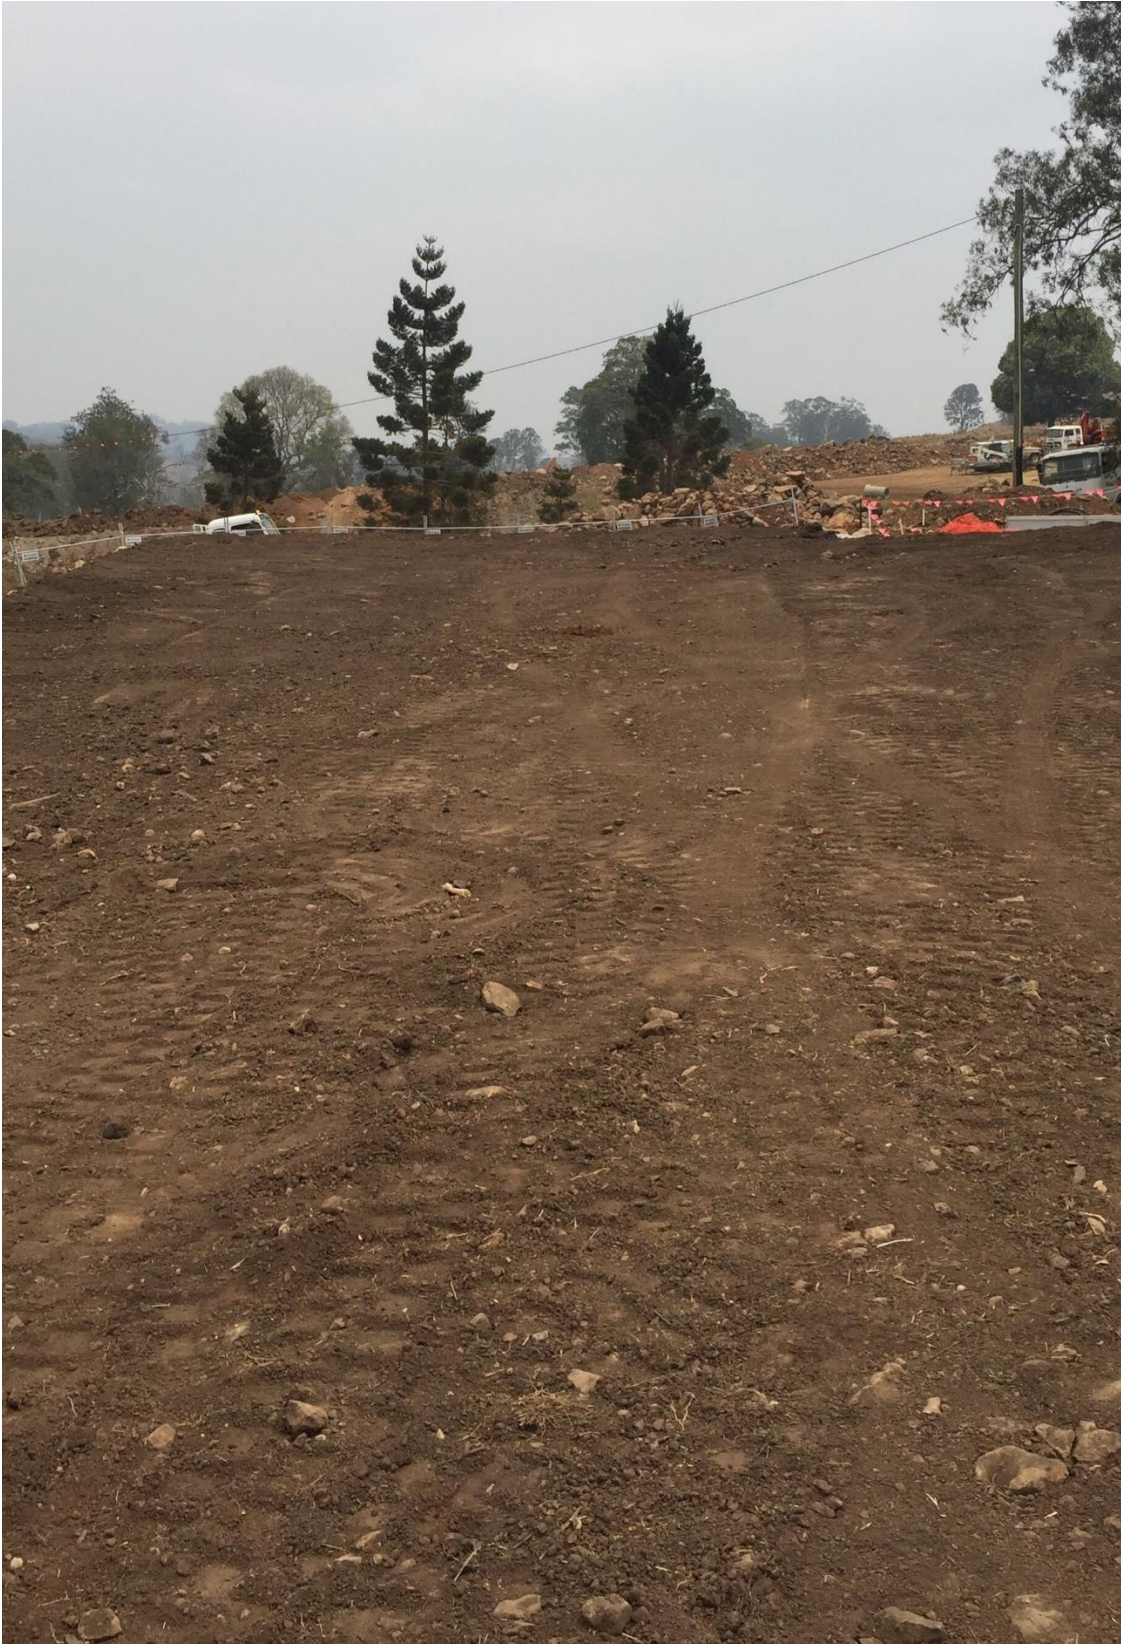
The sites surface is comprised of bare soil and is predominately flat.

A rock retaining wall up to 1.0m in height was observed along the western property boundary and up to 1.5m in height along the eastern property boundary.

Some outcropping of boulders is evident within the site.

View of the site facing a southerly direction.
