GEOTECHNICAL SITE INVESTIGATION

224 Invercauld Road Subdivision,
Stage 1B, Lot 105, Goonellabah,
NSW 2480.

ASCT Reference
[H19-1197.](#)

15th November 2019

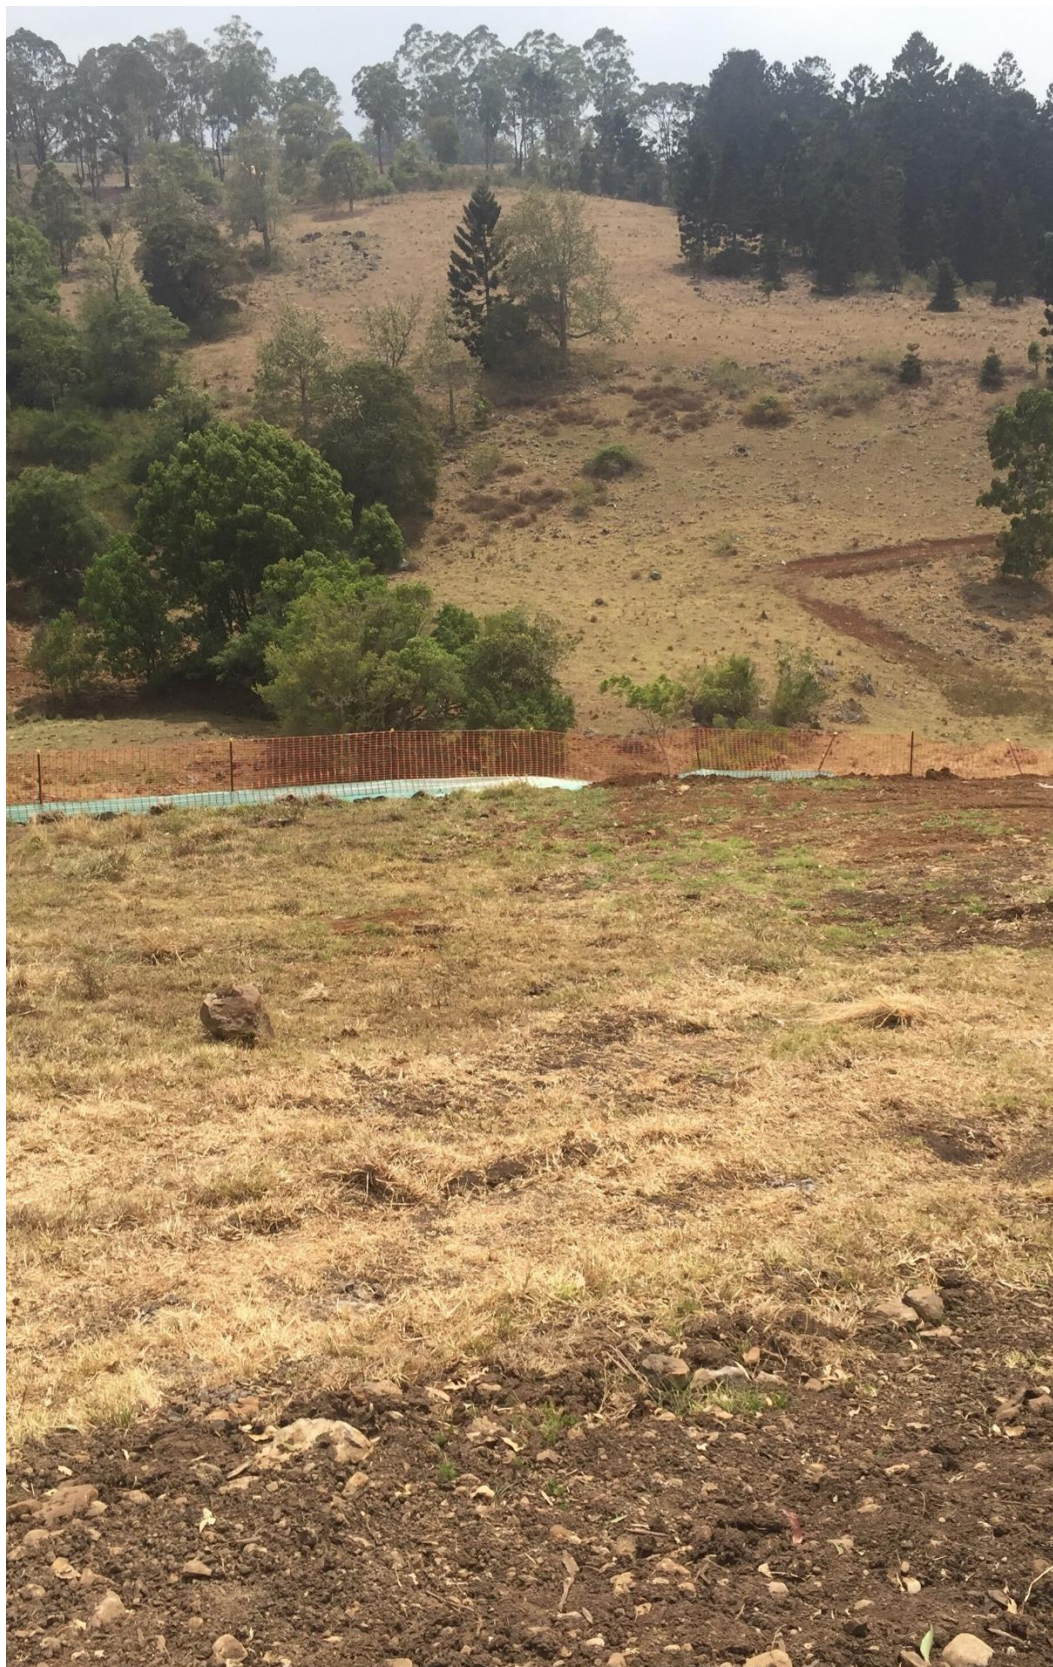
More specifically, the site is positioned in the mid-section of a north facing ridge. The sites surface is comprised of bare soil and slopes at approximately 15% towards the north. The batter at the front of the lot slopes steeply at approximately 30% towards the north.

Some outcropping of large boulders is evident within the site.

View of the site facing a northerly direction.

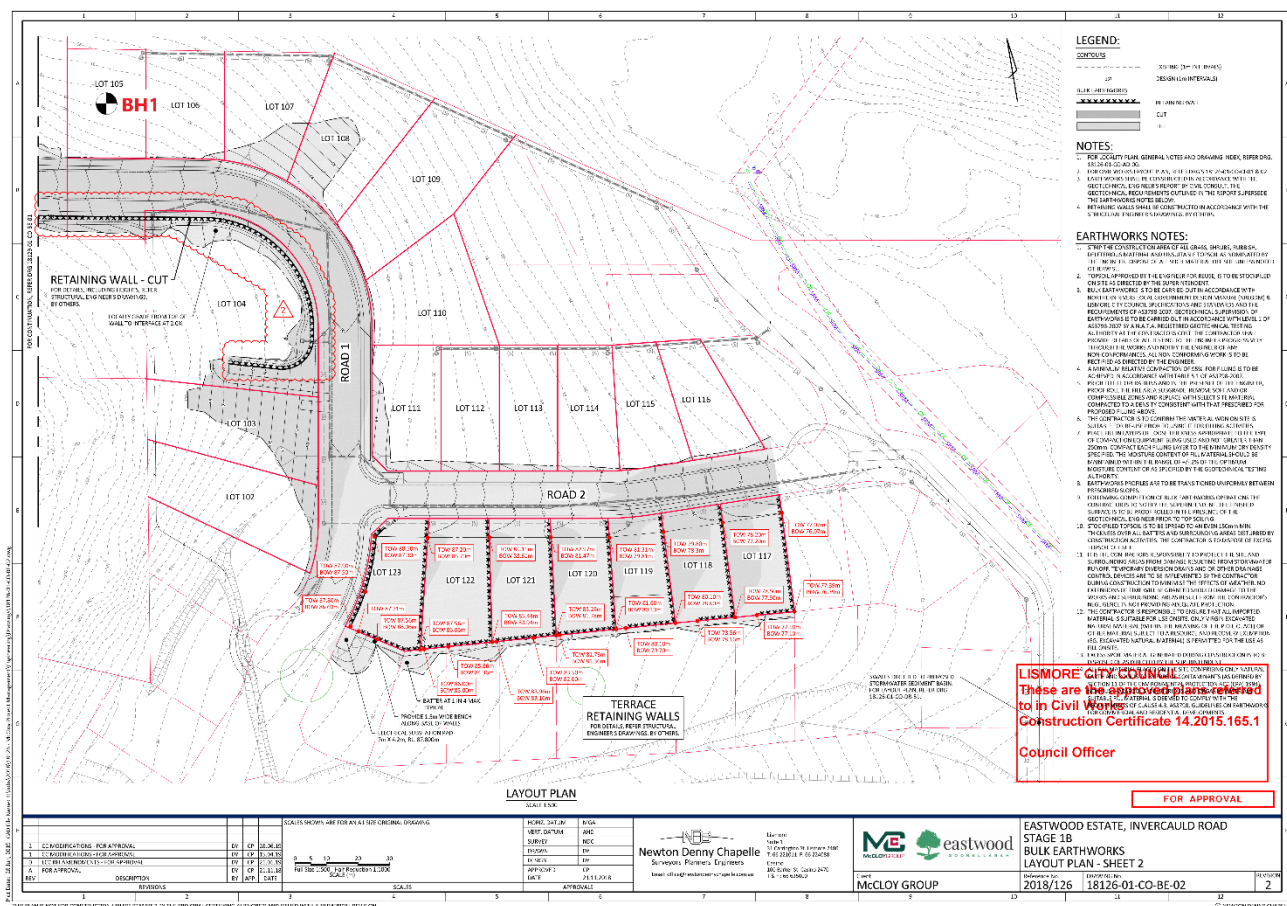
Plan of the site, with ASCT test positions (BH1).
