## GEOTECHNICAL SITE INVESTIGATION

224 Invercauld Road Subdivision,  
Stage 1B, Lot 108, Goonellabah,  
NSW 2480.

ASCT Reference  
[H19-1200.](#)

18<sup>th</sup> November 2019

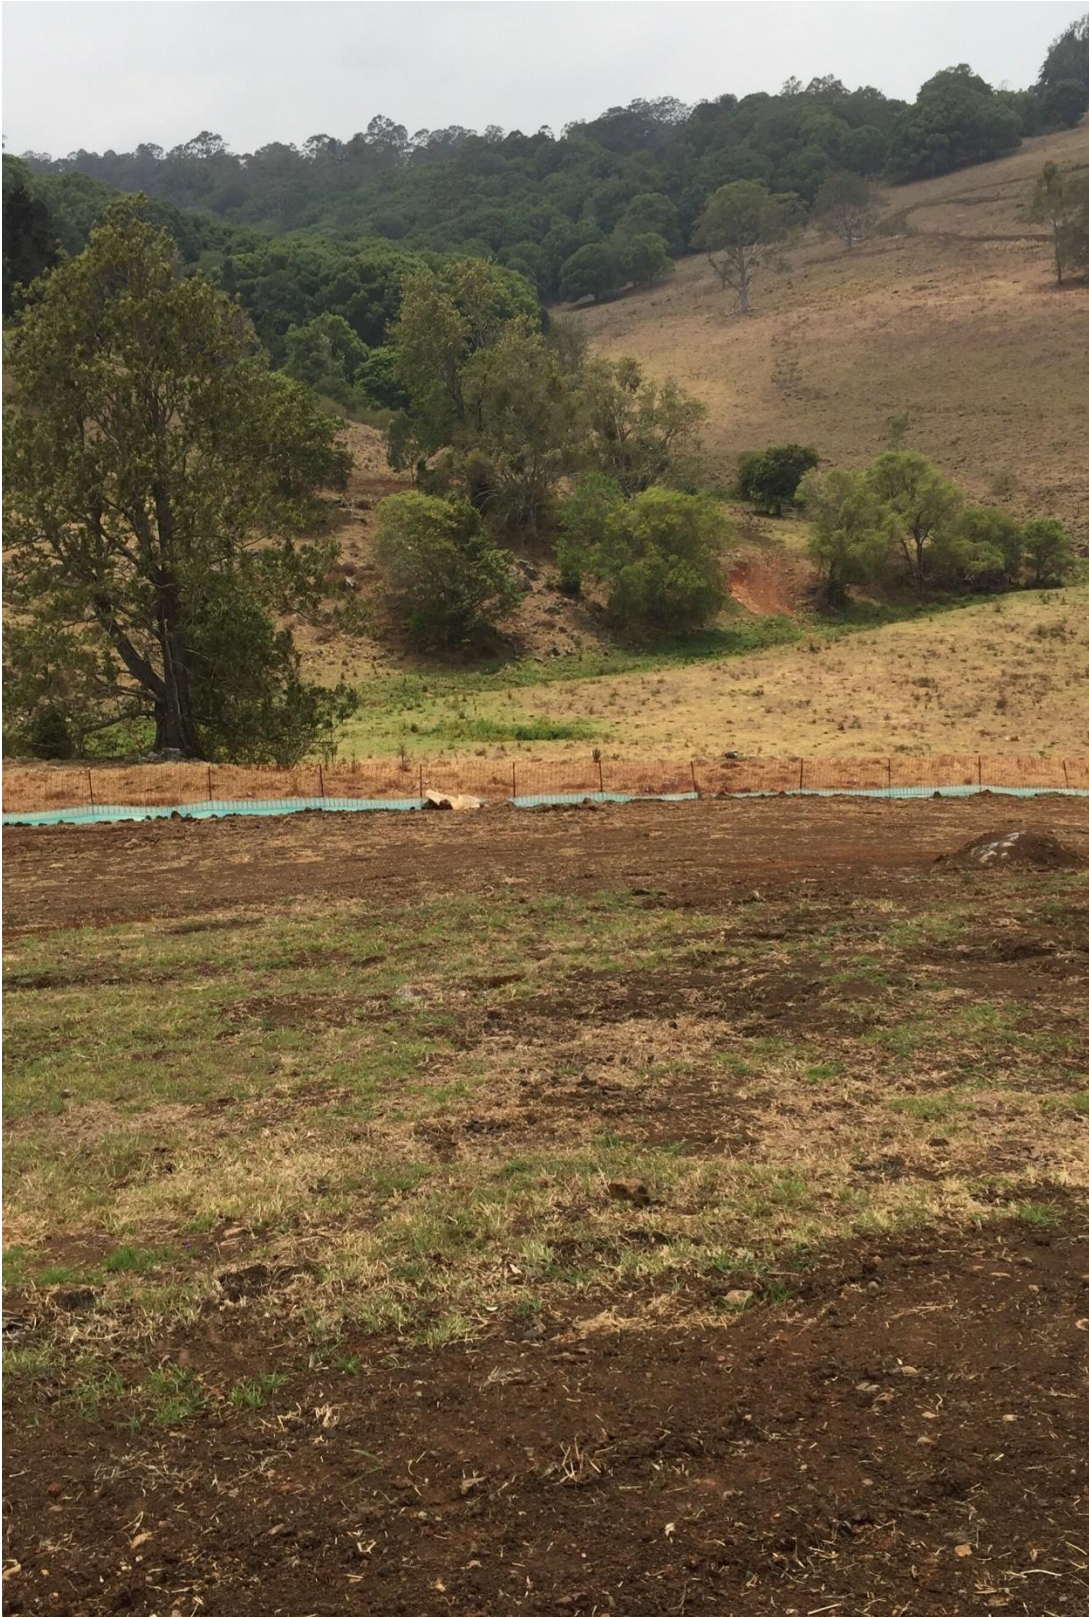
The sites surface is comprised of bare soil and slopes at approximately 20% towards the north east. The batter at the front of the lot slopes steeply at approximately 29% towards the north east.

Some outcropping of large boulders is evident within the site.

**View of the site facing a north easterly direction.**
