GEOTECHNICAL SITE

224 Invercauld Road Subdivision, Stage 1B, Lot 111, Goonellabah, NSW 2480.

ASCT Reference H19-1203.

18th November 2019

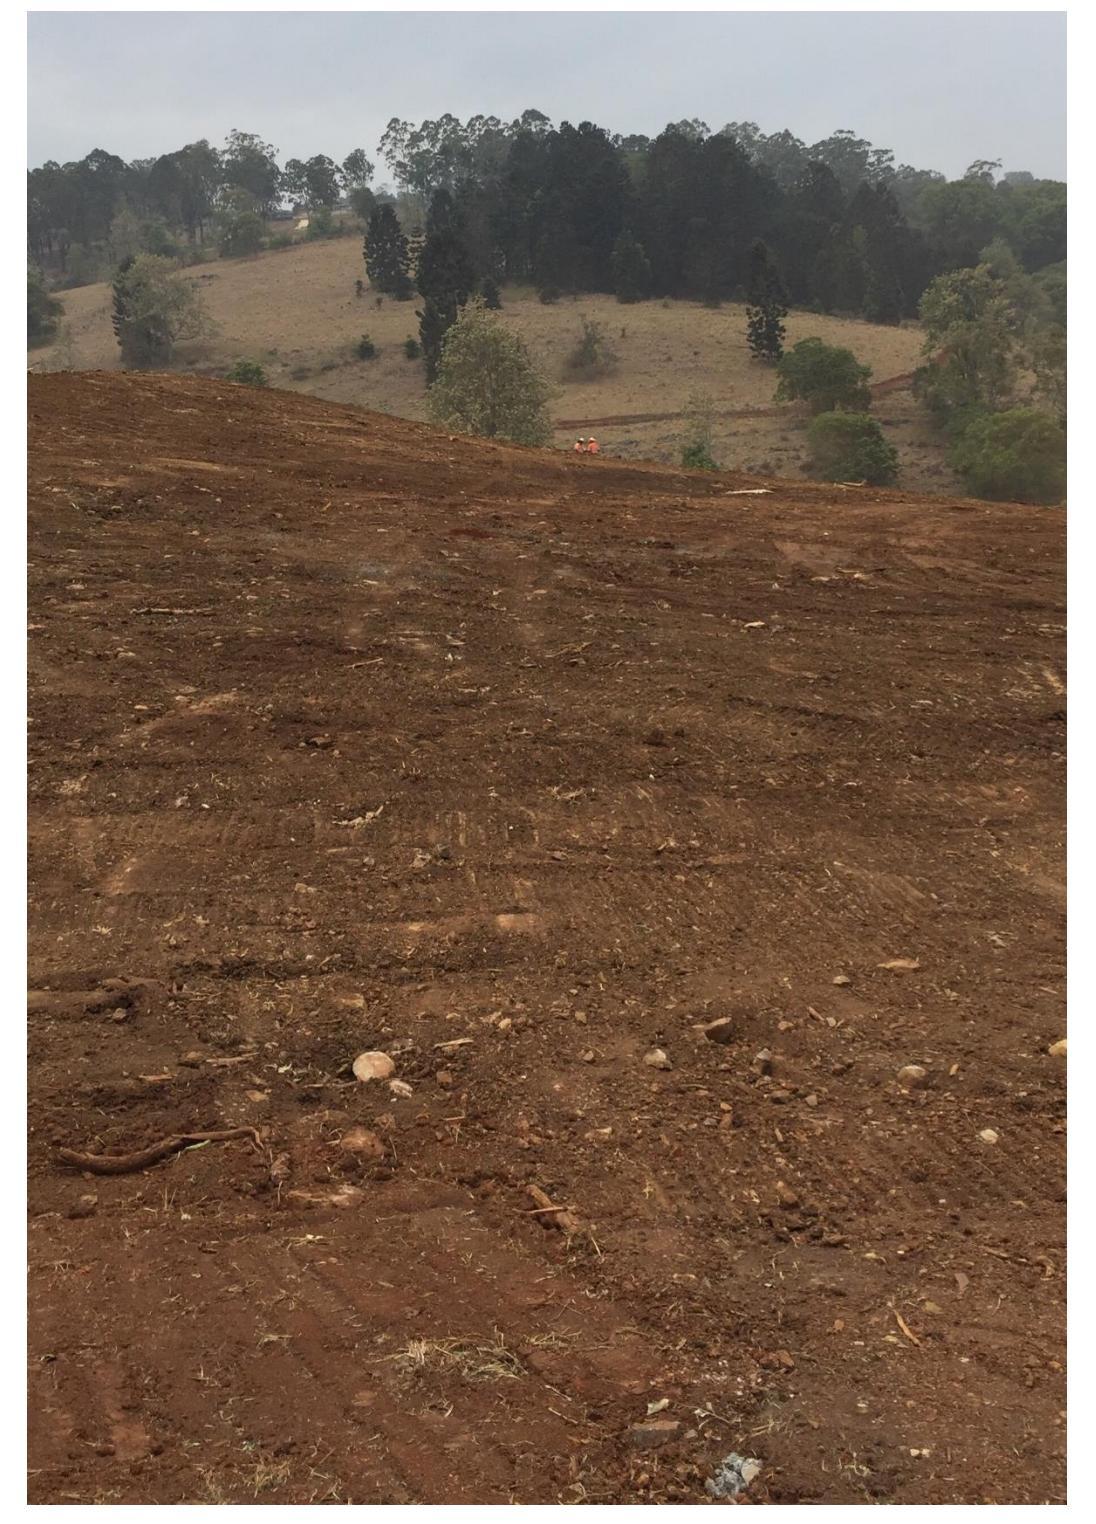
View of the site facing a northerly direction.

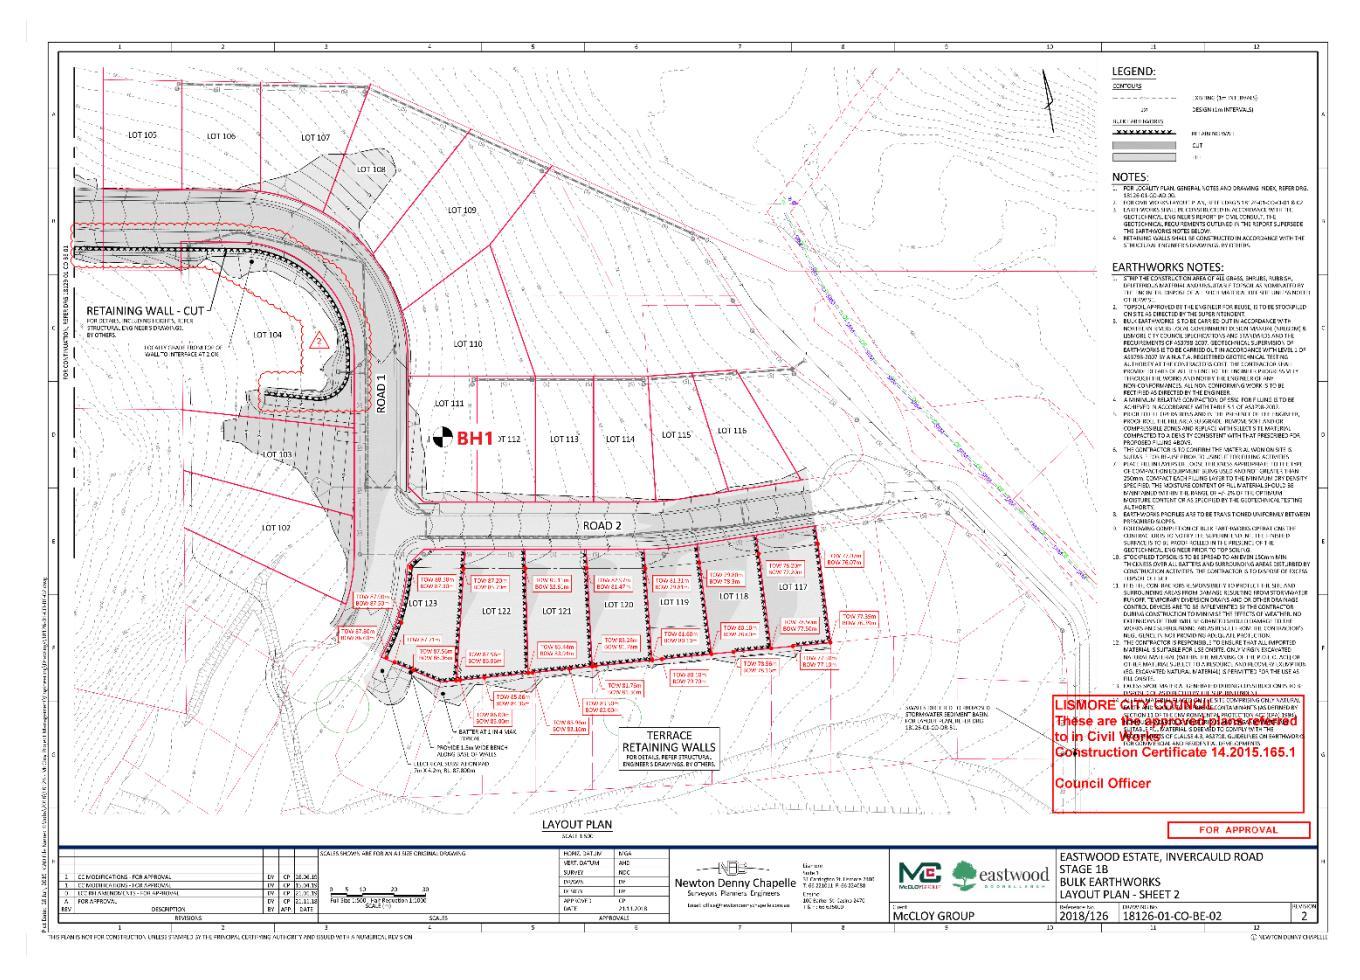
Plan of the site, with ASCT test positions.
