GEOTECHNICAL SITE INVESTIGATION

224 Invercauld Road Subdivision,
Stage 1B, Lot 112, Goonellabah,
NSW 2480.

ASCT Reference
[H19-1204.](#)

18th November 2019

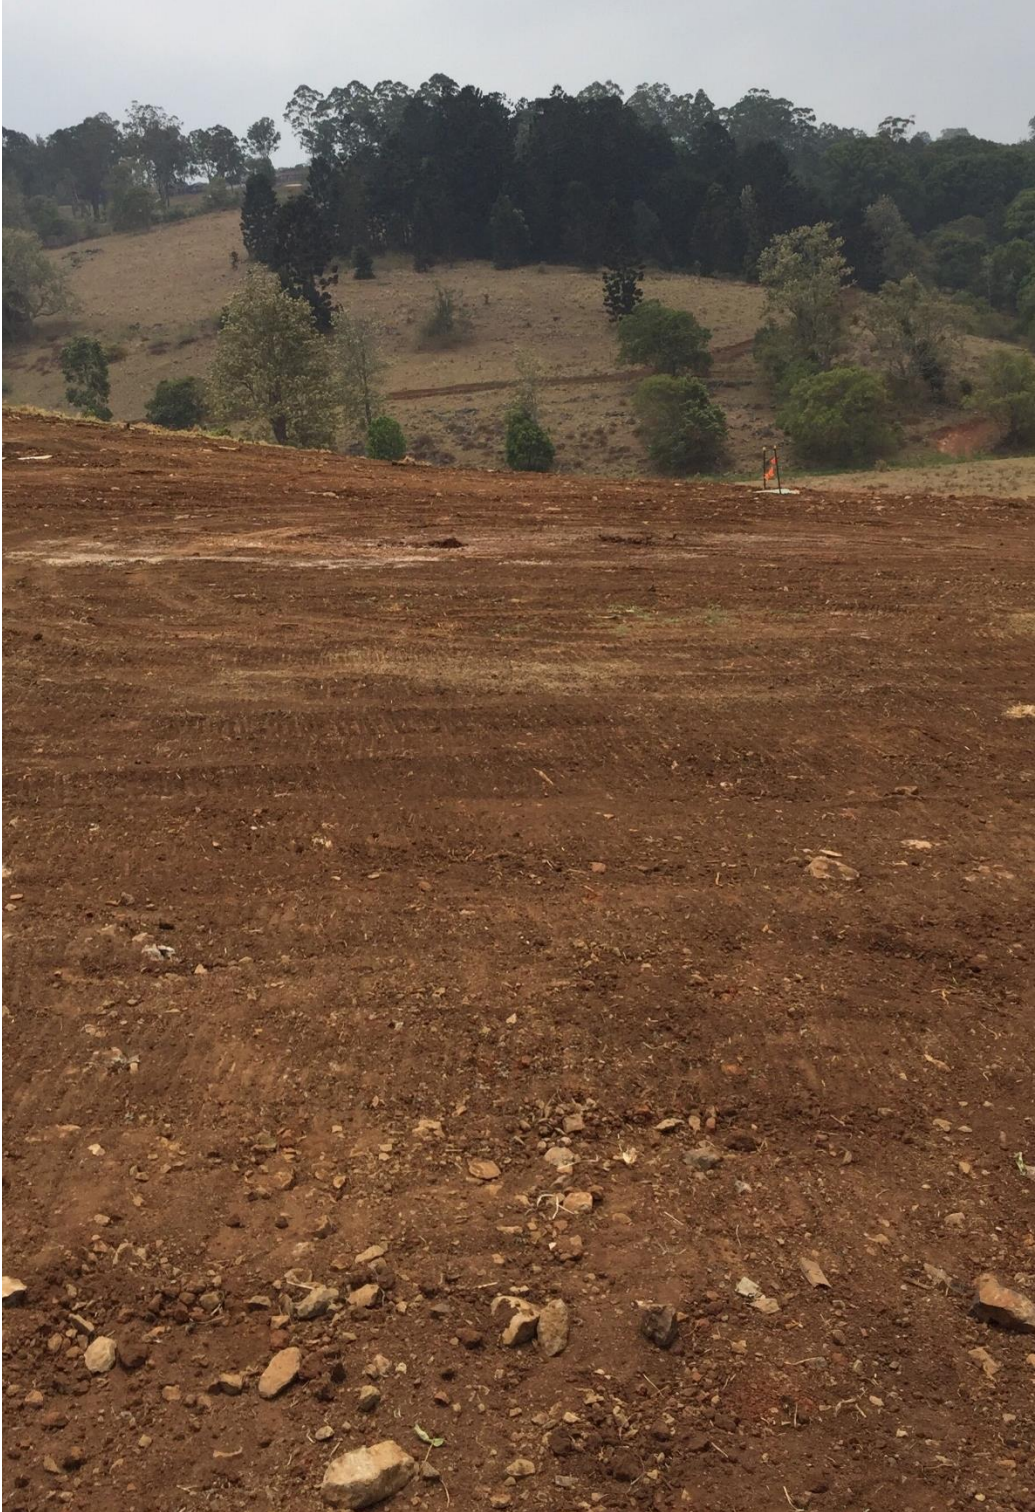
More specifically, the site is positioned in the mid-section of an east facing ridge. The sites surface is comprised of bare soil and slopes at approximately 10% towards the east north-east.

Some outcropping of large boulders is evident within the site.

View of the site facing a northerly direction.
