GEOTECHNICAL SITE INVESTIGATION

224 Invercauld Road Subdivision,
Stage 1B, Lot 113, Goonellabah,
NSW 2480.

ASCT Reference
[H19-1205.](#)

18th November 2019

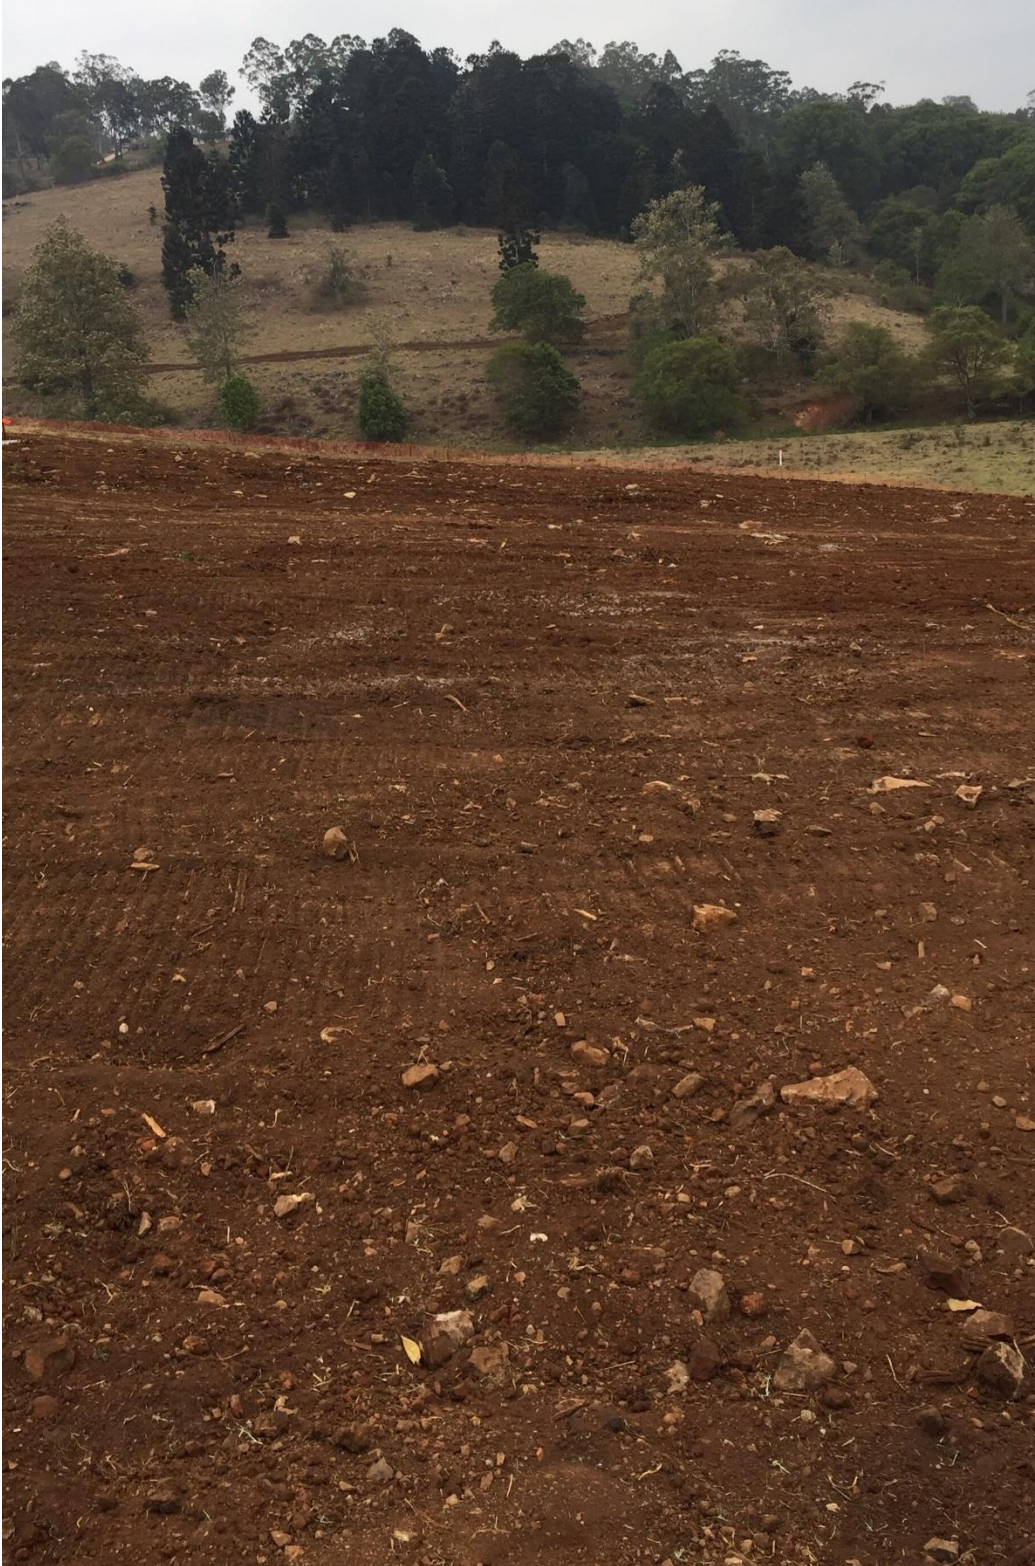
View of the site facing a northerly direction.
