## GEOTECHNICAL SITE INVESTIGATION

### SUBJECT SITE

224 Invercauld Road Subdivision,  
Stage 1B, Lot 114, Goonellabah,  
NSW 2480.

**Ref No: H19-1206.**

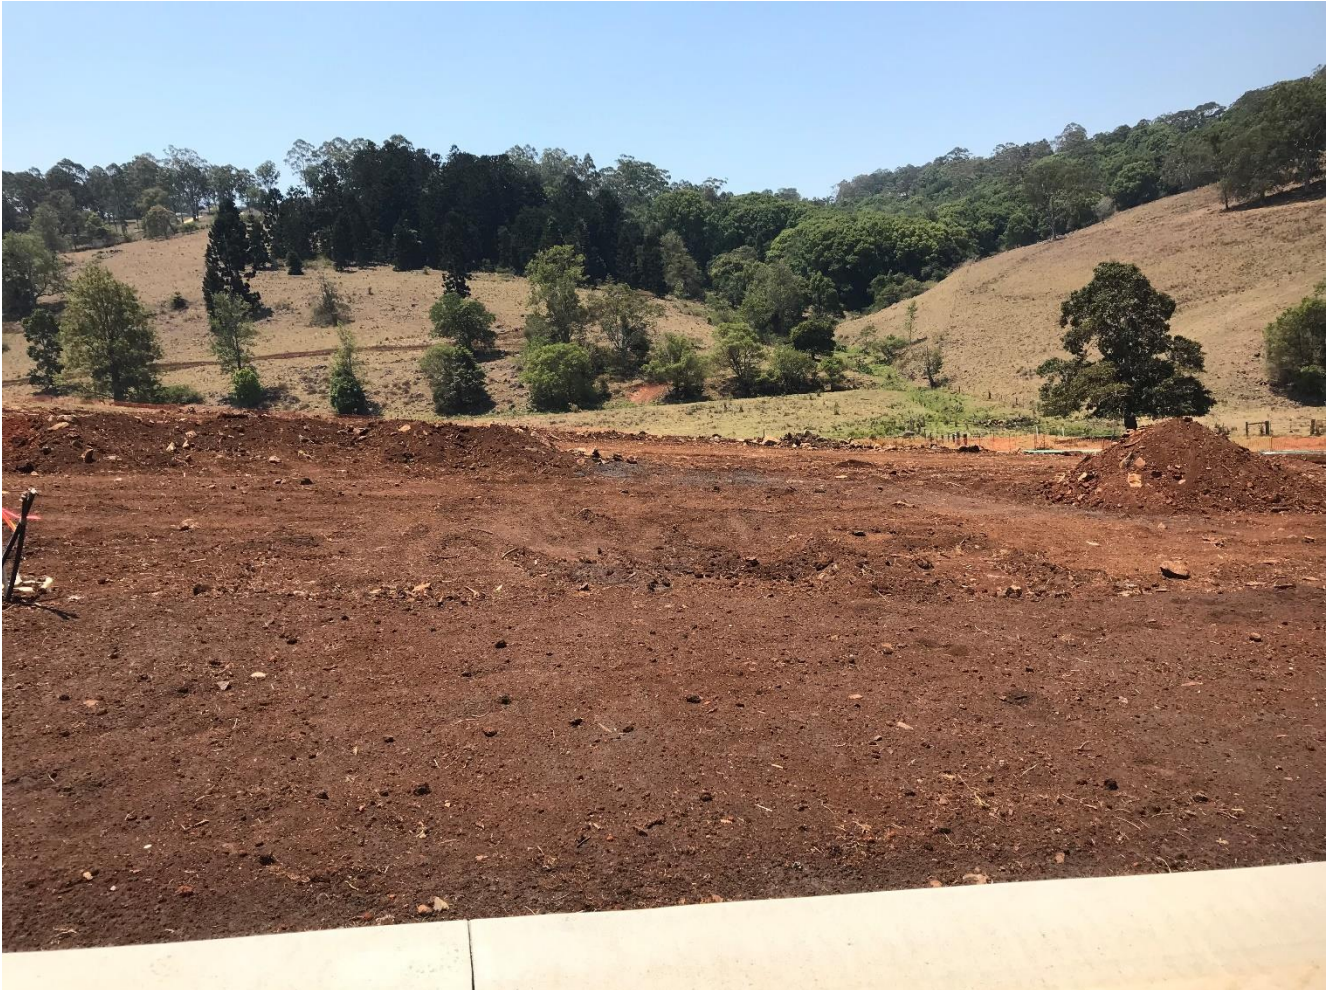
**View of the site facing a north north-easterly direction.**
