## GEOTECHNICAL SITE INVESTIGATION

Prepared by ASCT - Ballina office,  
for McCloy Group.

224 Invercauld Road Subdivision,  
Stage 1B, Lot 115, Goonellabah,  
NSW 2480.

ASCT Reference  
[H19-1207.](#)

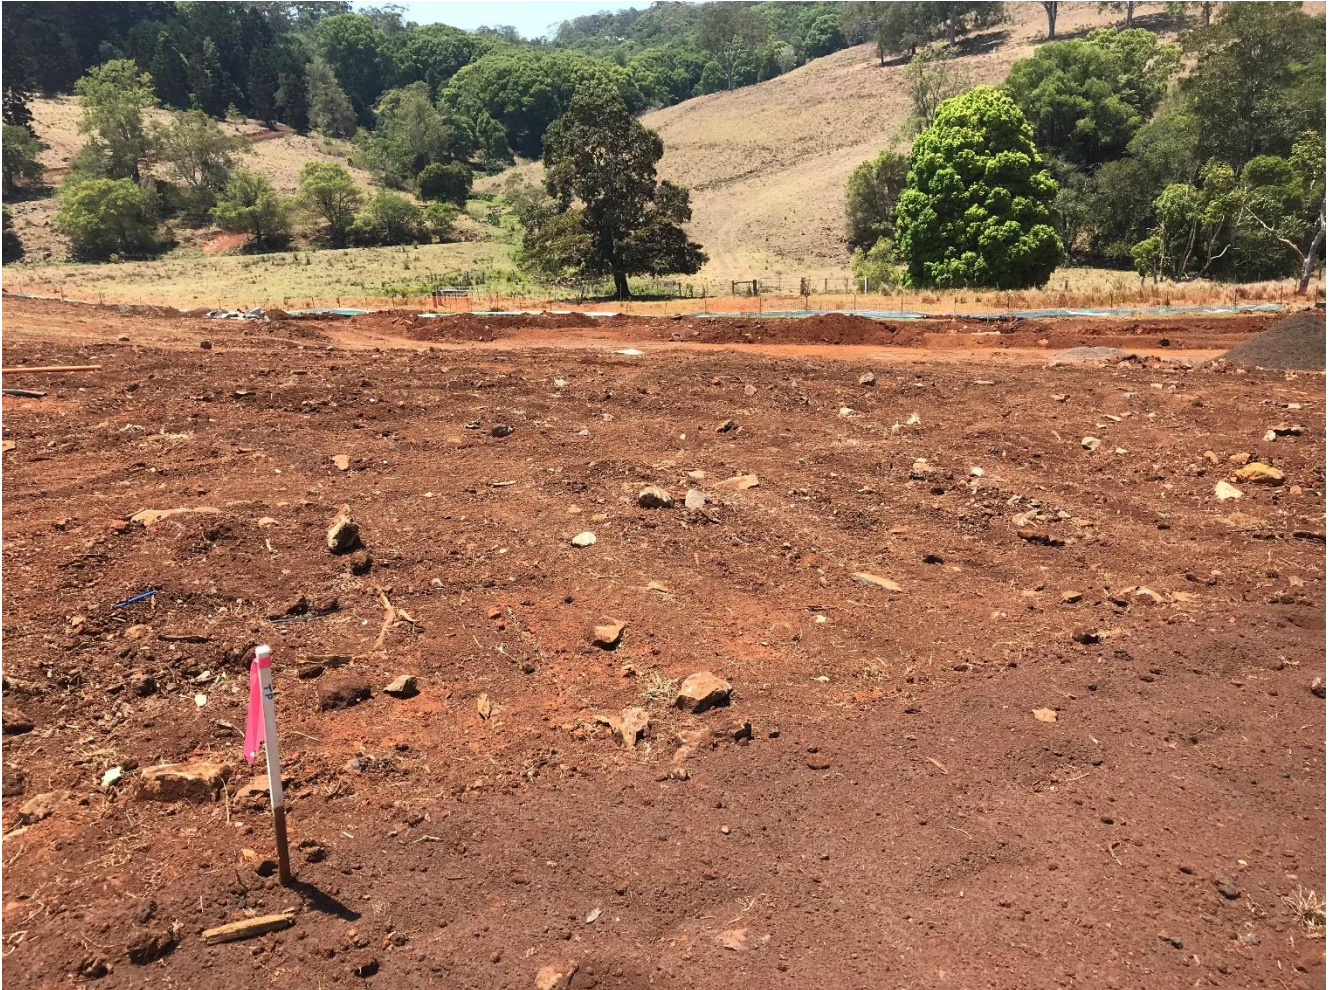
**View of the site facing a north easterly direction.**
