# **BUSHFIRE ATTACK LEVEL**

## **FUTURE DWELLINGS**

### **AT STAGE 5**

# **EASTWOOD GOONELLABAH**

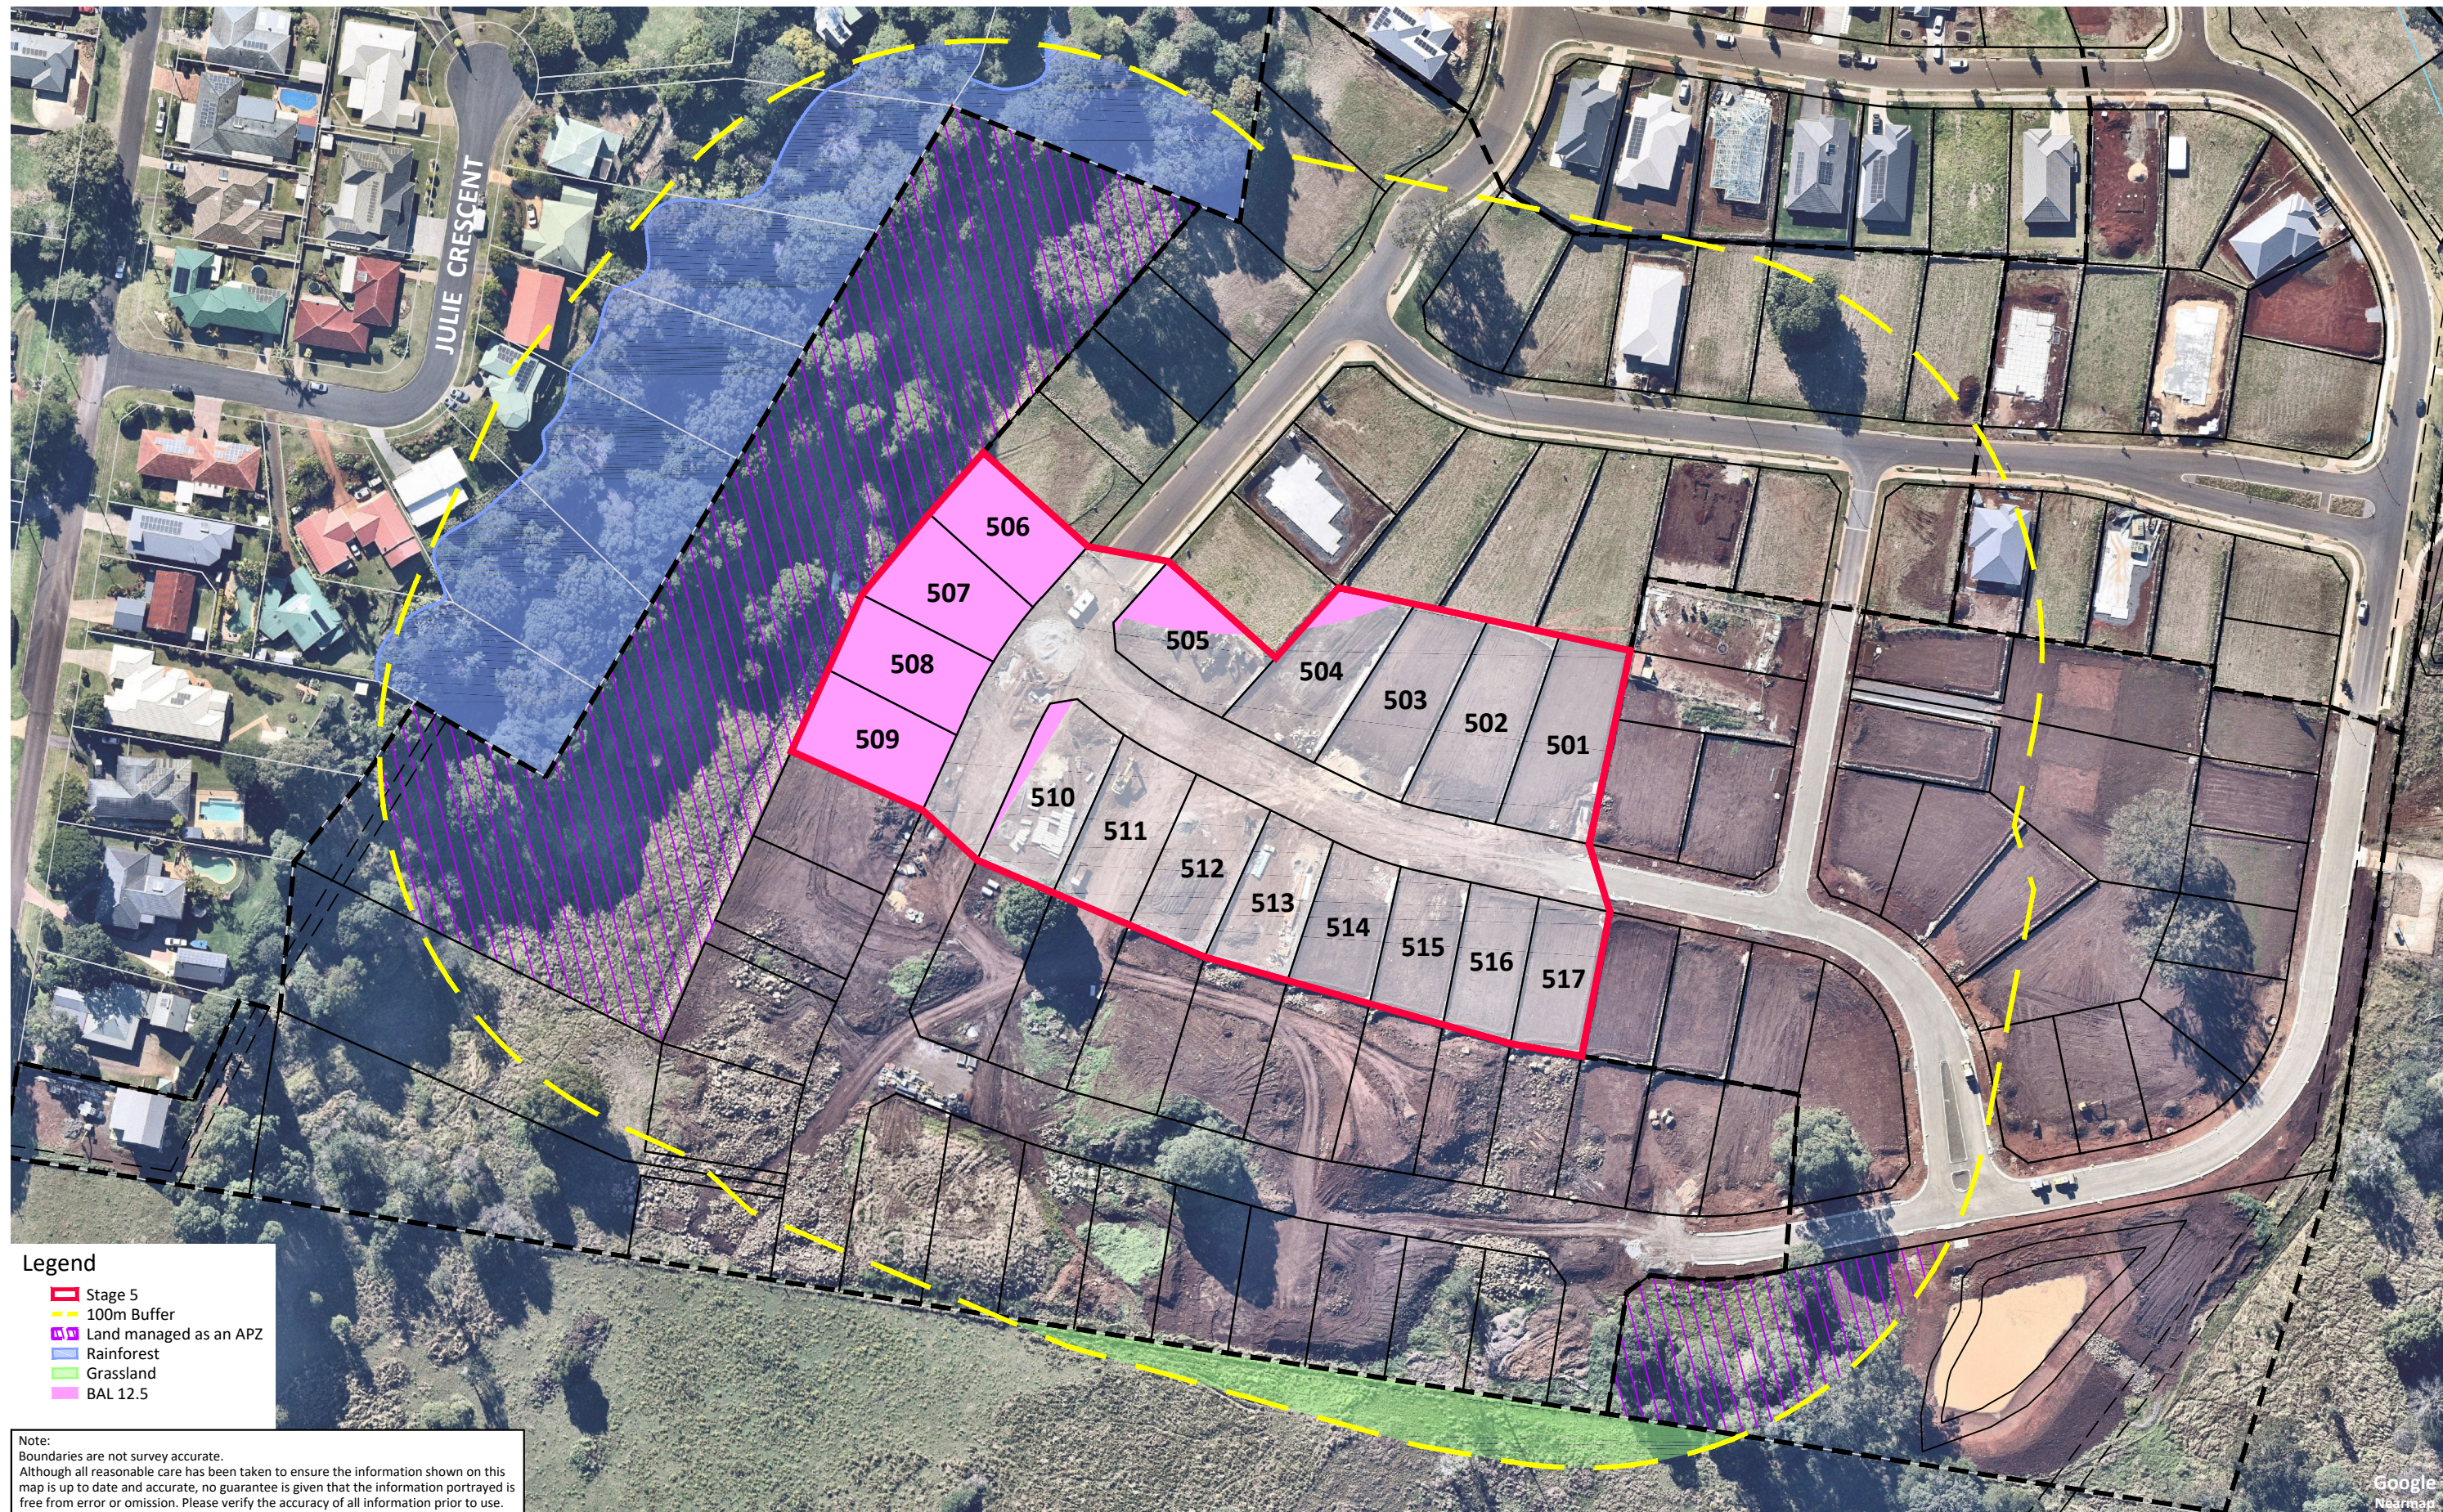
FIGURE 5-1: BUSHFIRE ATTACK LEVELS MAP

The results from this bush fire attack assessment are detailed below in Table 4-1– Bushfire Attack Level (BAL) Assessment and Figure 4-1 Bushfire Attack Level Map.

Lot Number	Vegetation Type within 100m & Direction from future dwellings	Average Slope of Land (degrees)	Separation Distance from Identified Vegetation (m)	Bushfire Attack Level (BAL)	Construction Section
501	Remnant vegetation to the West	Upslope	>100m	BAL-LOW	N/A
502	Remnant vegetation to the West	Upslope	>100m	BAL-LOW	N/A
503	>100m	BAL-LOW	N/A	>100m	BAL-LOW
504	Remnant vegetation to the West	Upslope	20-<100m	BAL-12.5	Sect 3 & 5 of AS3959 and Sect 7.5 of PBP.
			>100m	BAL-LOW	N/A
505	Remnant vegetation to the West	Upslope	20-<100m	BAL-12.5	Sect 3 & 5 of AS3959 and Sect 7.5 of PBP.

Lot Number	Vegetation Type within 100m & Direction from future dwellings	Average Slope of Land (degrees)	Separation Distance from Identified Vegetation (m)	Bushfire Attack Level (BAL)	Construction Section
			>100m	BAL-LOW	N/A
506	Remnant vegetation to the West	Upslope	20-<100m	BAL-12.5	Sect 3 & 5 of AS3959 and Sect 7.5 of PBP.
507	Remnant vegetation to the West	Upslope	20-<100m	BAL-12.5	Sect 3 & 5 of AS3959 and Sect 7.5 of PBP.
508	Remnant vegetation to the West	Upslope	20-<100m	BAL-12.5	Sect 3 & 5 of AS3959 and Sect 7.5 of PBP.
509	Remnant vegetation to the West	Upslope	20-<100m	BAL-12.5	Sect 3 & 5 of AS3959 and Sect 7.5 of PBP.
510	Remnant vegetation to the West	Upslope	20-<100m	BAL-12.5	Sect 3 & 5 of AS3959 and Sect 7.5 of PBP.
			>100m	BAL-LOW	N/A
511	N/A	-	>100m	BAL-LOW	N/A
512	N/A	-	>100m	BAL-LOW	N/A
513	N/A	-	>100m	BAL-LOW	N/A
514	N/A	-	>100m	BAL-LOW	N/A
515	N/A	-	>100m	BAL-LOW	N/A
516	N/A	-	>100m	BAL-LOW	N/A

517	N/A	-	>100m	BAL-LOW	N/A
